Final Technical Report

INERI 2003-008-K

Developing and Evaluating Candidate
Materials for Generation IV Supercritical
Water Reactors

J. I. Cole, J. L. Rempe and T. C. Totemeier, Idaho National
Laboratory

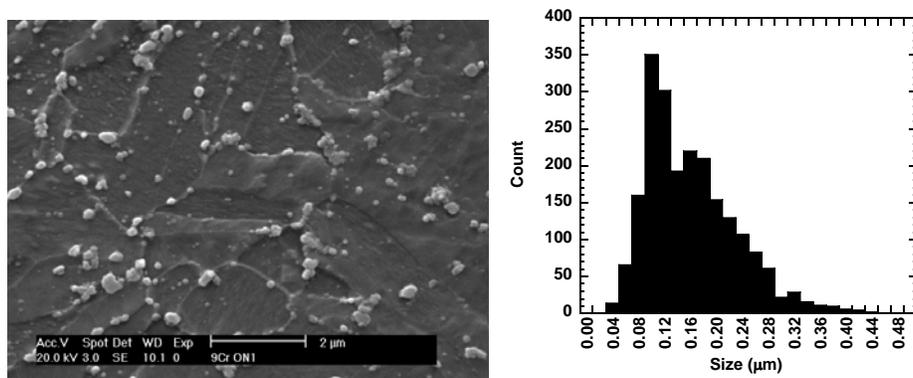
Figure 6 Typical SEM image of etched microstructure and resulting carbide size distribution.

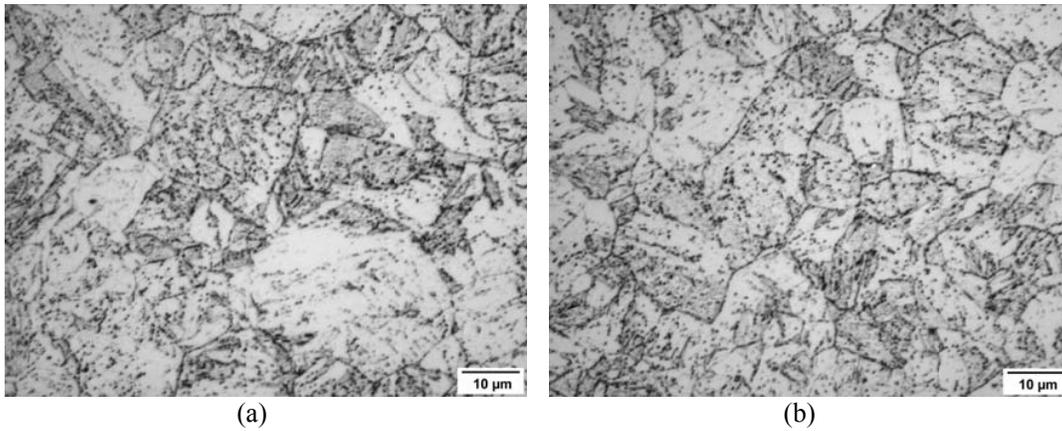
Figure 7 Optical microstructure of Grade 91 steel (heat 1): (a) baseline prior to cycling, (b) after five transient cycles to 840 °C maximum temperature.

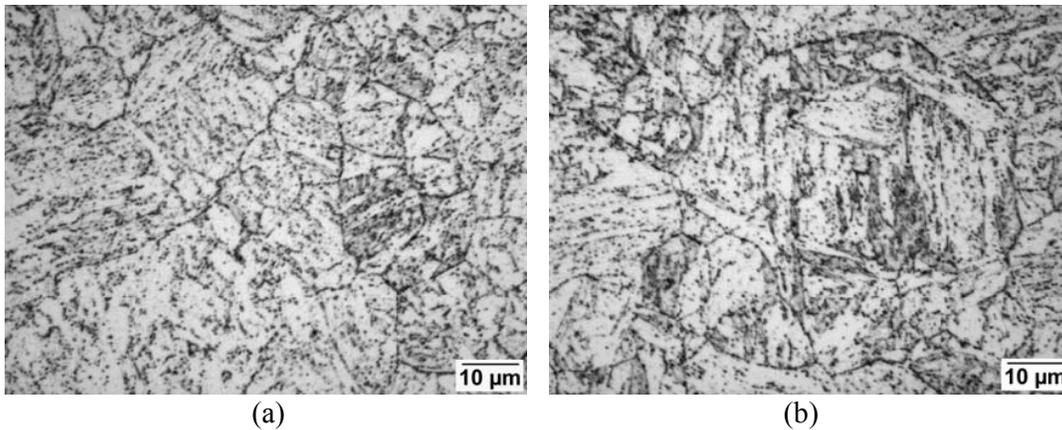
Figure 8 Optical microstructure of Grade 122 steel: (a) baseline prior to cycling, (b) after five transient cycles to 840 °C maximum temperature.

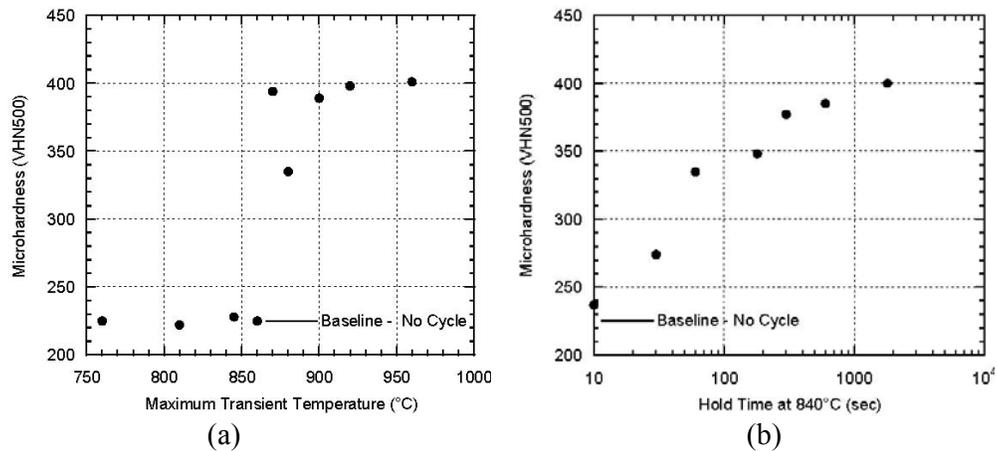
Figure 9 Variation of Grade 91 (heat 2) post-transient microhardness with (a) maximum transient temperature without hold, (b) hold time at 840 °C maximum transient temperature.

respectively. Also indicated are the pre-cycling baseline hardness values. No change in microhardness was observed for maximum cycle temperatures of 860°C and below; for transient temperatures above 860°C the microhardness dramatically increased to a plateau level of 400 VHN₅₀₀. Hold periods at 840°C greater than 10 s resulted in microhardness that increased with hold duration; a maximum microhardness of 400 VHN₅₀₀ was observed after 1800 s holding at 840°C. Etched optical microstructures observed after cycling reflected the microhardness changes; significant fractions of untempered martensite were observed for maximum transient temperatures of 870°C and above and 840 °C hold periods greater than 10 s. Typical baseline and cycled structures are shown in Figure 10; lightly etched areas in the cycled microstructures are untempered martensite.

The effects of varied maximum transient temperature and hold time at 840°C transient temperature on the microhardness of Grade 91 steel are shown in Figure 9a and Figure 9b,

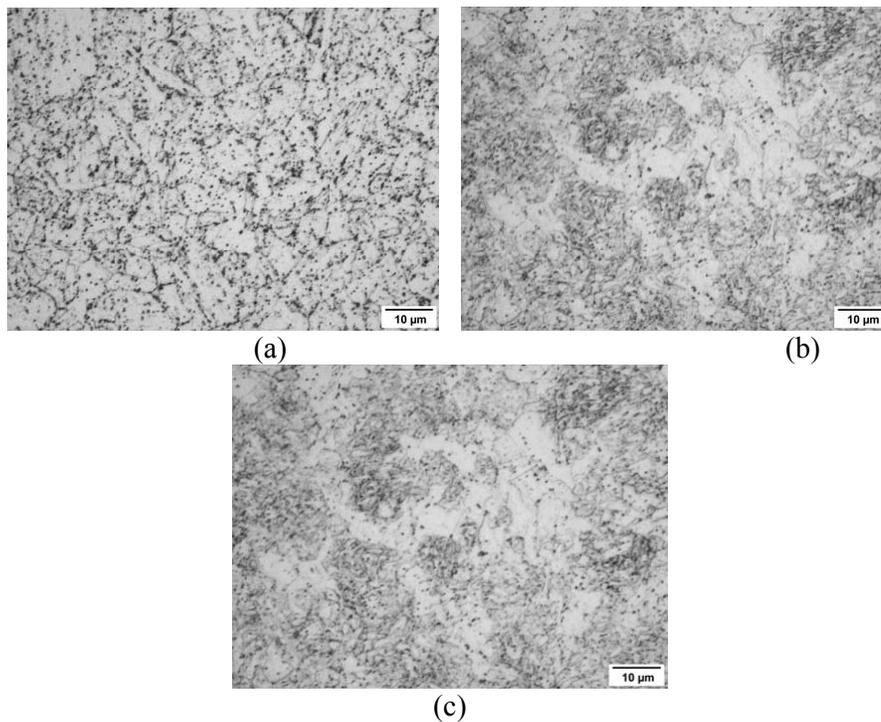
Figure 10 Optical microstructure of Grade 91 steel (heat 2): (a) baseline prior to cycling, (b) 870°C maximum transient temperature, (c) 30 s hold time at 840°C maximum transient temperature.

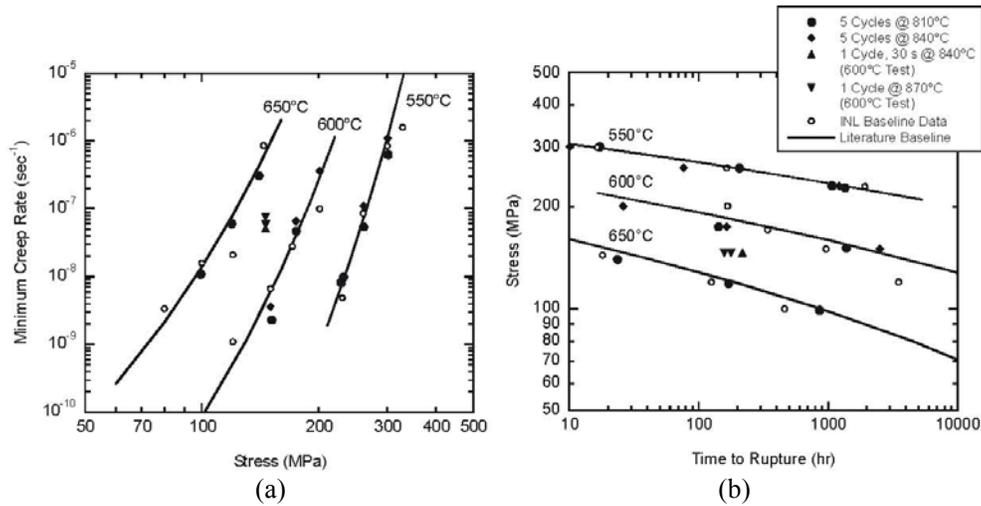
Figure 11 Comparison of (a) minimum creep rate and (b) rupture life for transient-cycled Grade 91 steel with baseline data.

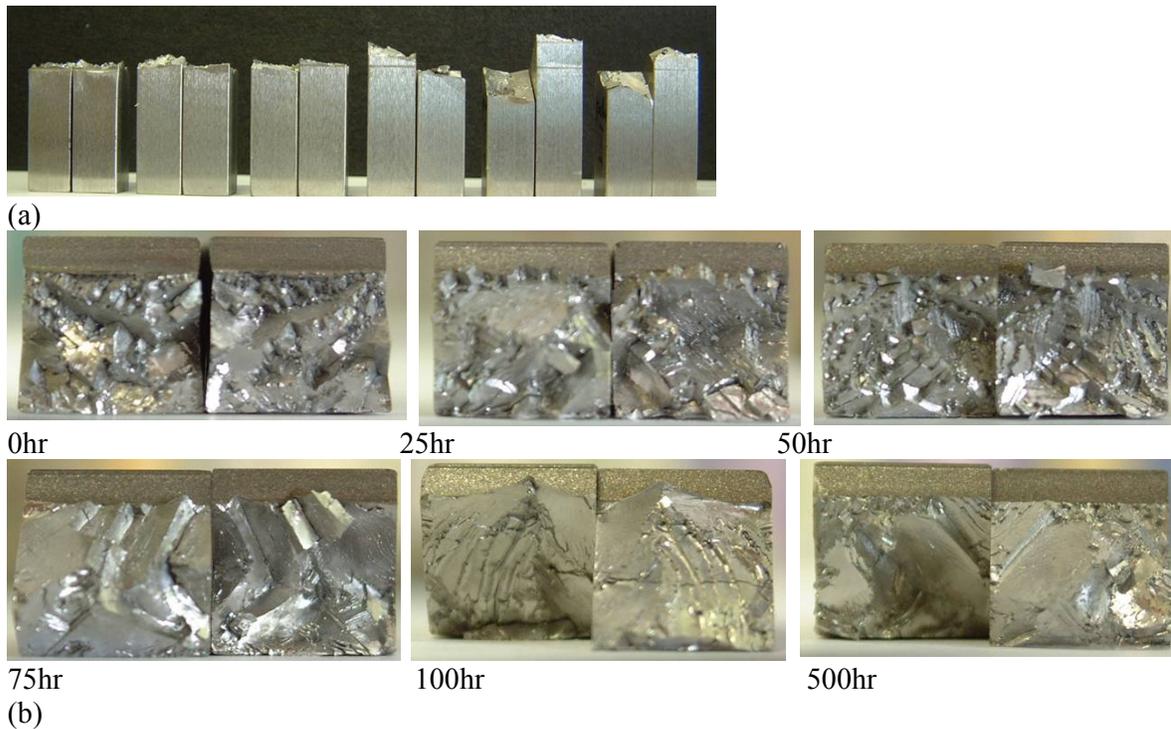
Figure 22 Fracture surface of Charpy impact tested MA956 rod. (a) side view(time increases from left to right) (b) top view.

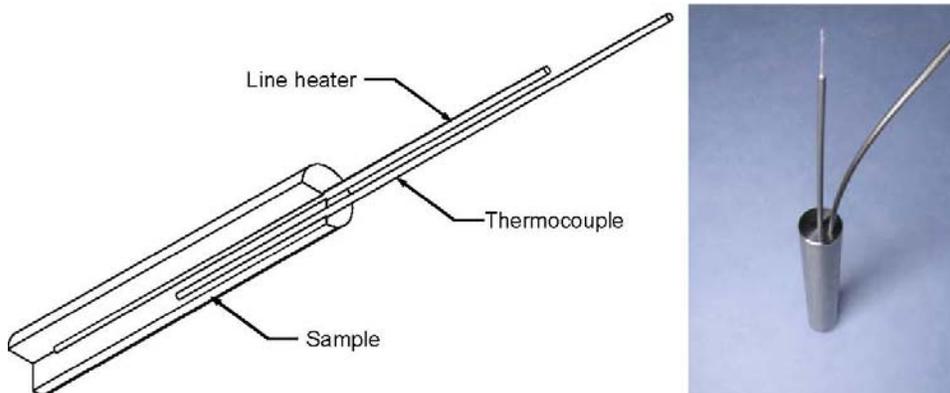
Figure 25 Sketch and photo of sample with heater and thermocouple installed.

Figure 25 shows a sketch of the design initially proposed for investigating this method. A heater is placed in the center of the sample that extends nearly the entire length of the sample. The heater element is constructed similar to a thermocouple. However, a single wire with high electrical resistivity (e.g., rhenium or molybdenum) is threaded through two-hole, high temperature electrical insulation material (e.g., hafnia); and its ends are connected to power leads at the top. The threaded wires are placed in a high temperature sheath material (e.g., niobium alloy) and then swaged to form an integral heater. For initial temperature measurements, commercially-available thermocouples were used (e.g., Type K chromel/alumel). However, higher-temperature, in-pile testing will require INL-developed thermocouples composed of alloys of molybdenum and niobium thermocouples that resist transmutation [1].

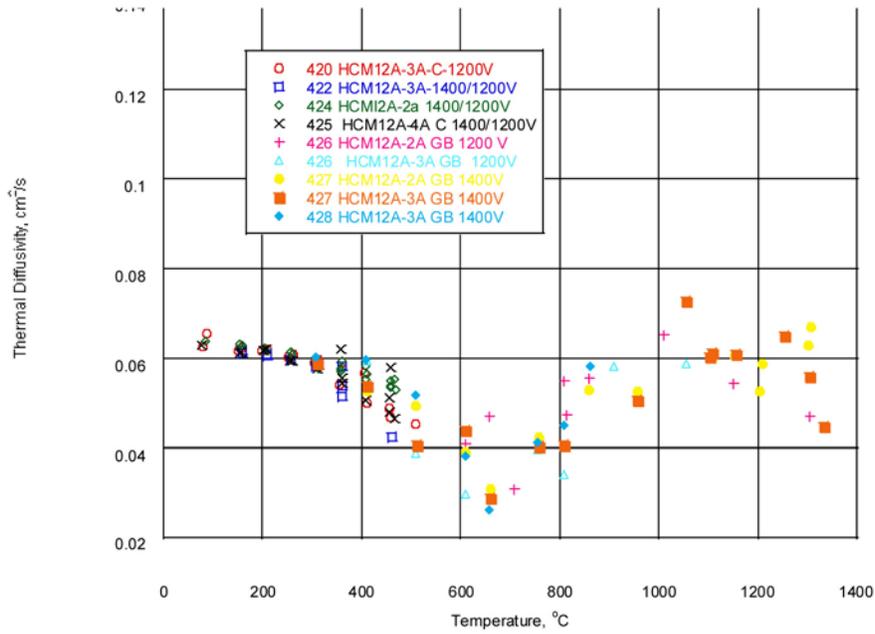
Figure 39 INL HCM12A thermal diffusivity data.

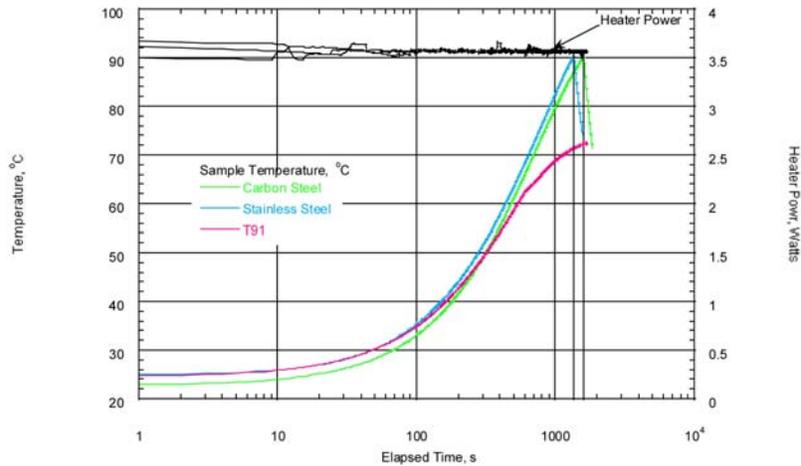
Figure 43 Results from room temperature hot wire tests.

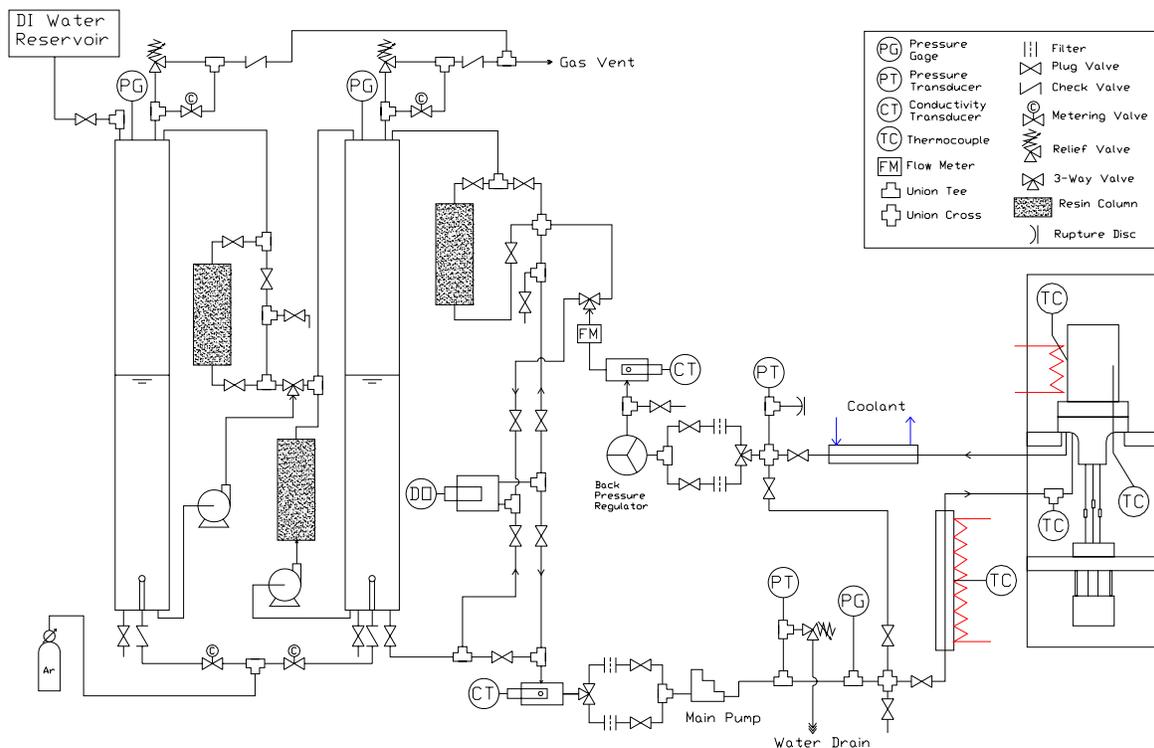
Figure 46 Schematic of multi-sample SCW-SCC facility in HTCL.

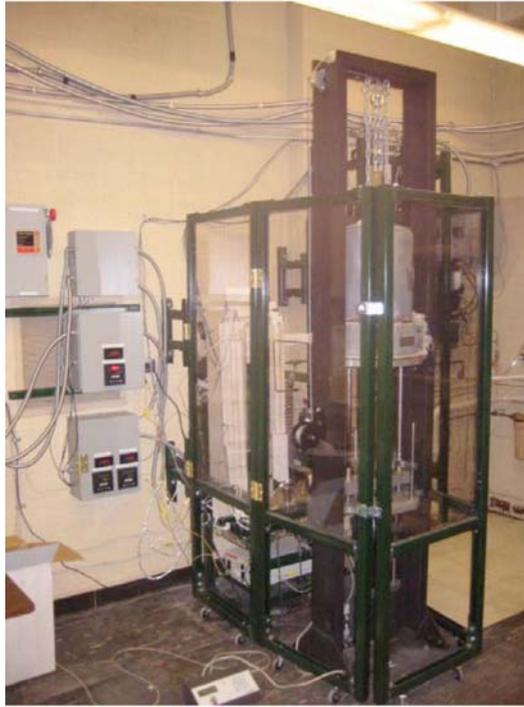
Figure 47 Photograph of the multi-sample SCW-SCC facility in HTCL.

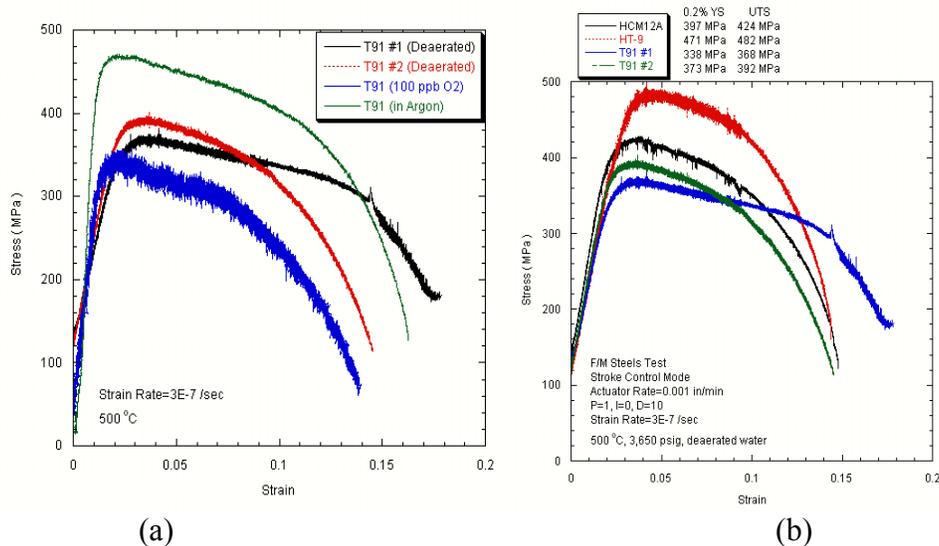
Figure 49 Engineering stress-strain curves for (a) F/M steels tested in deaerated SCW and (b) T91 compared with the results tested in 100 ppb DO SCW and pure Ar gas.

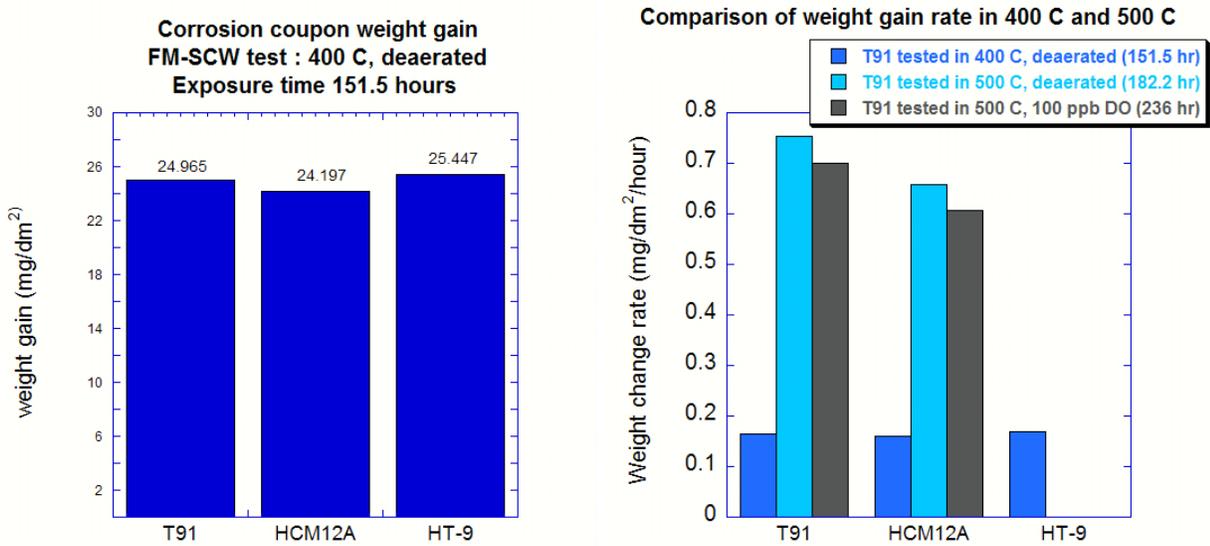
Figure 59 Comparison of weight gain of F-M alloys in supercritical water (a) 3 alloys in deaerated 400°C supercritical water (b) T91 as a function of temperature and oxygen concentration.

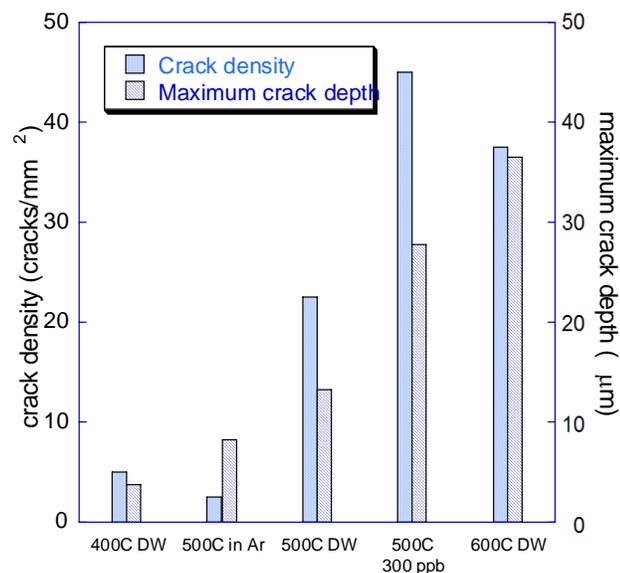
Figure 65 Summary of cracking behavior of HT-9 in supercritical water.

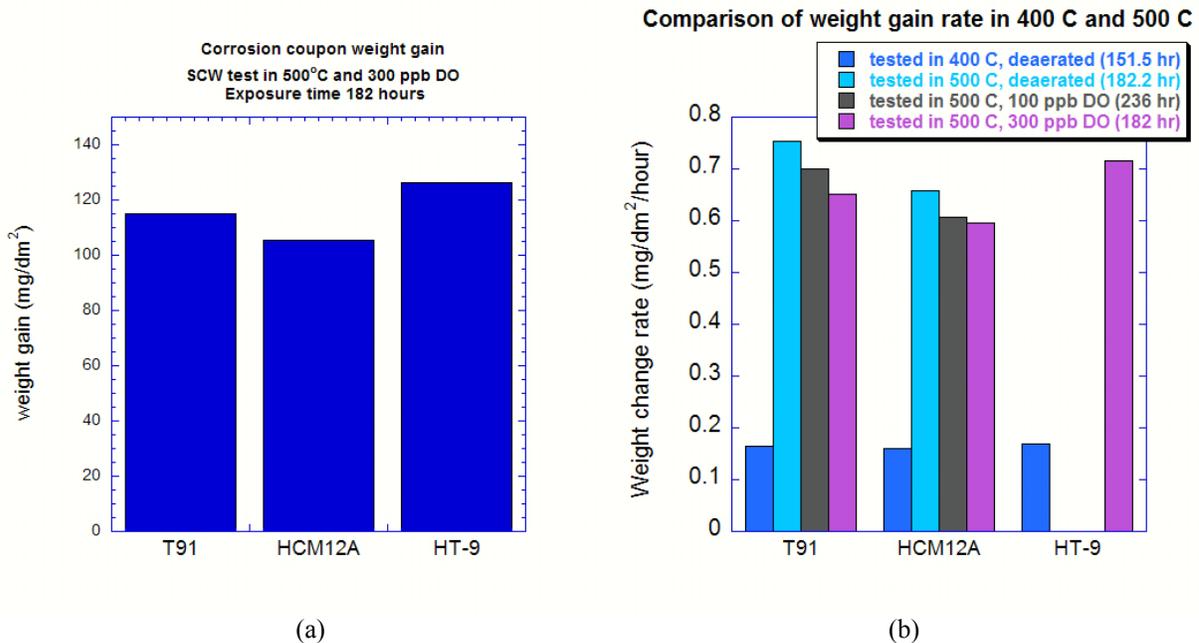
Figure 66 Comparison of weight gain of F-M alloys in supercritical water (a) 3 alloys in 300ppb 500°C supercritical water (b) as a function of temperature and oxygen concentration.

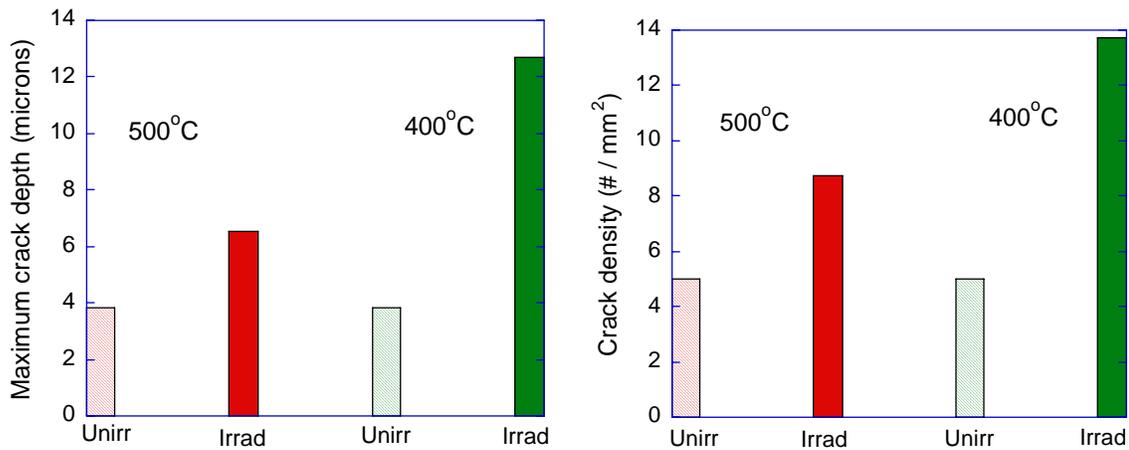
Figure 69 IG cracking in HT-9 irradiated to 7 dpa at 400°C or 500°C and tested in 400°C SCW

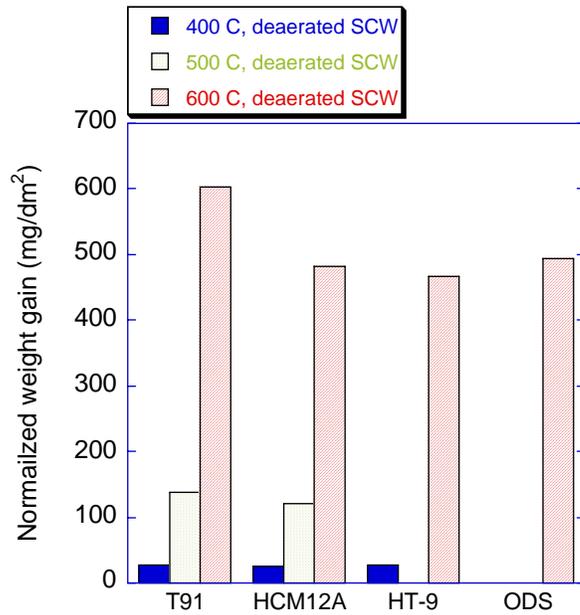
Figure 70 Temperature dependence: in Deaerated SCW for ~ 200 hr.

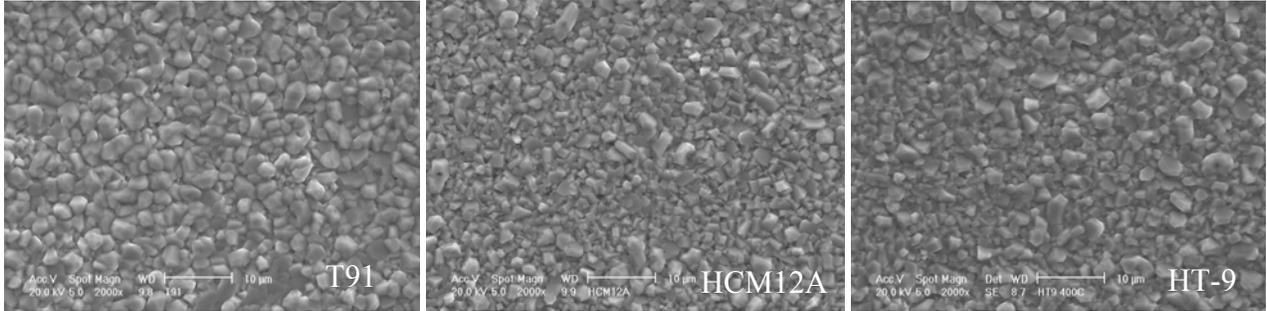
Morphology of oxide on T91, HCM12A, and HT-9 corrosion coupon exposed in 400°C deaerated for 151.5 hours

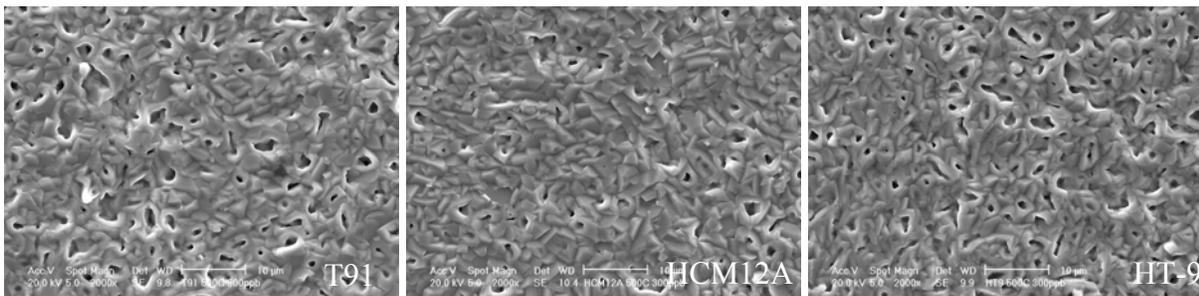
Morphology of oxide on T91, HCM12A, and HT-9 corrosion coupon exposed in 500°C 300 ppb DO for 182 hours

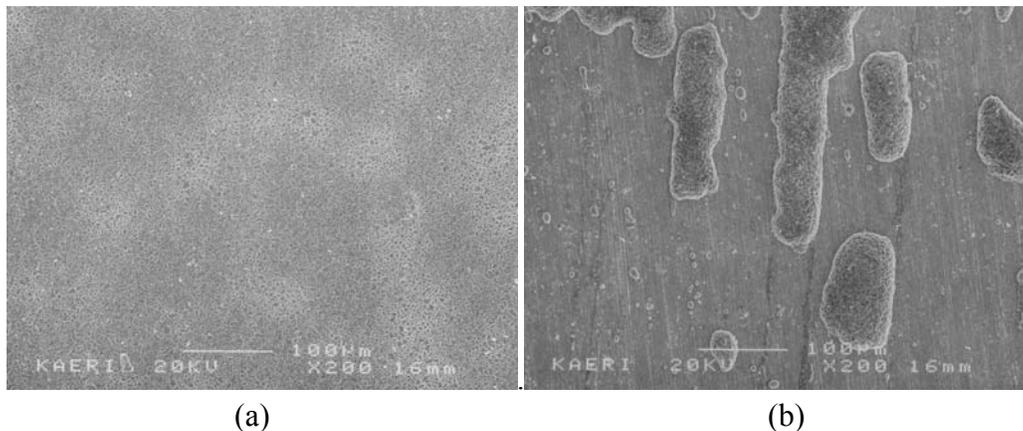
Figure 75 Specimen surface of (a) T91 and (b) HCM12A (T122) after SCW corrosion test at 627 C (900 K), 25 MPa for 200 hours.

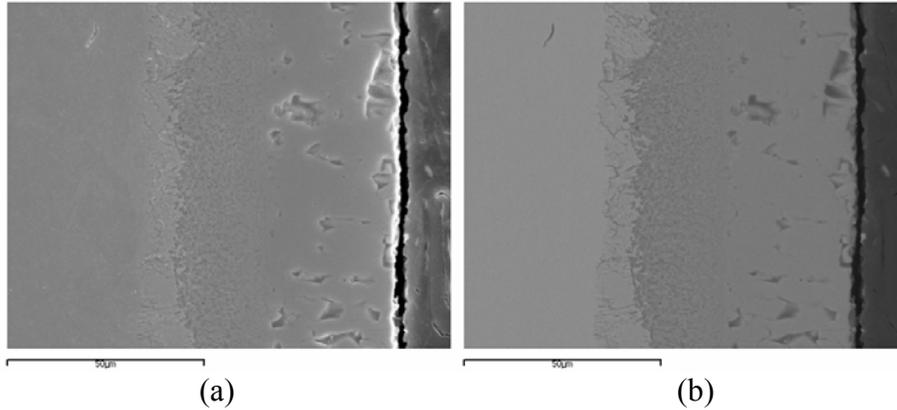
Figure 79 SEM micrographs of the cross section of T91 specimen after corrosion test (a) SEI (Secondary Electron Image) (b) BEI (Backscattered Electron Image).

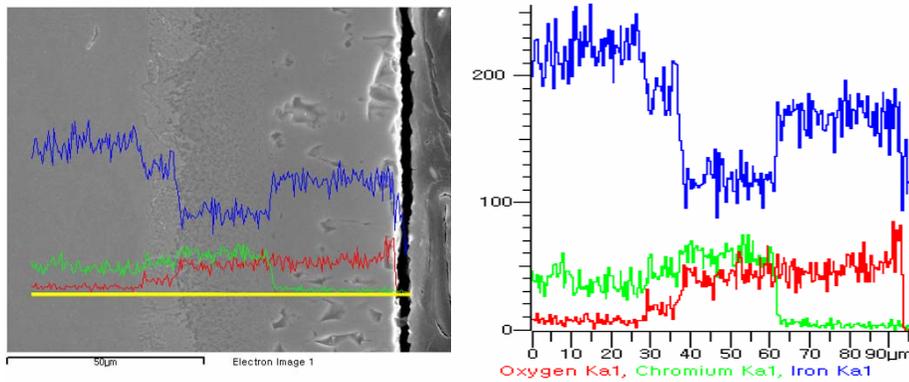
Figure 80 Line profiles of Fe, Cr, and O across the oxide layers on T91 specimen.

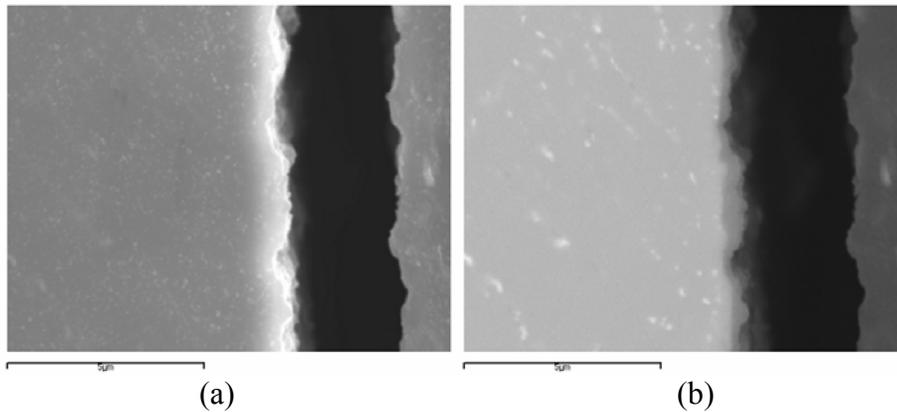
Figure 81 SEM micrographs of the cross section of HCM12A (T122) specimen after corrosion test (a) SEI (Secondary Electron Image) (b) BEI (Backscattered Electron Image).

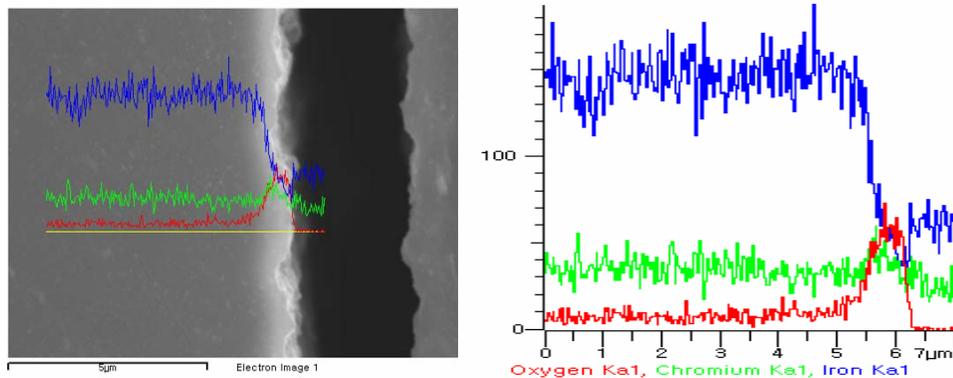
Figure 82 Line profile of Fe, Cr, and O across the oxide layers on HCM12A (T122) specimen.

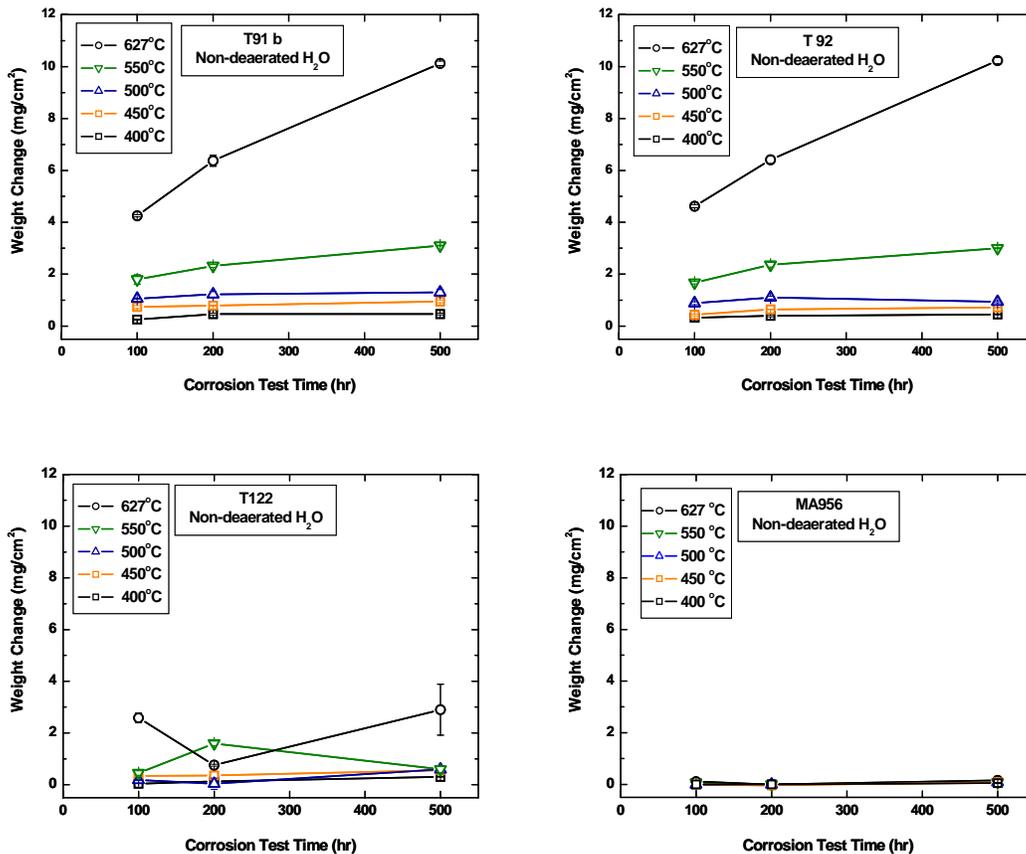
Figure 83 SCW Corrosion Test Result; High Cr Steels (T91, T92, HCM12A & MA 956).

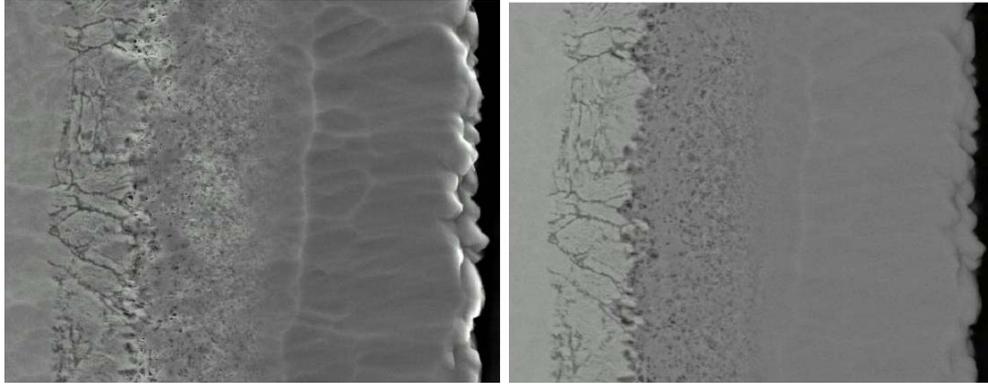
Figure 84 SEM of T91 Cross Section after SCW Corrosion Test (627 °C / 200hr).

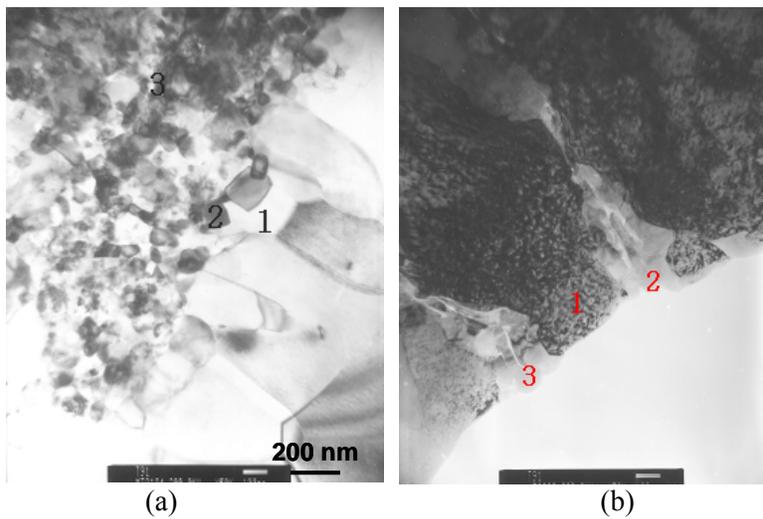
Figure 85 (a) XTEM of Oxide Layers of T91 after 200 hr at 627 °C / 25MPa. (b) XTEM of Internal Oxidation Zone of T91 after 200 hr at 627 °C / 25MPa .

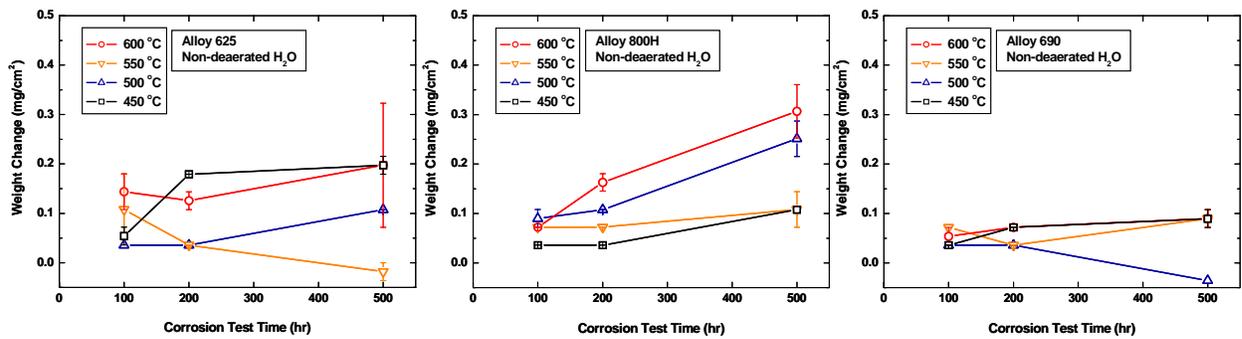
Figure 87 SCW Corrosion Test Result; high Ni Alloys (I 625, 800H, & 690).

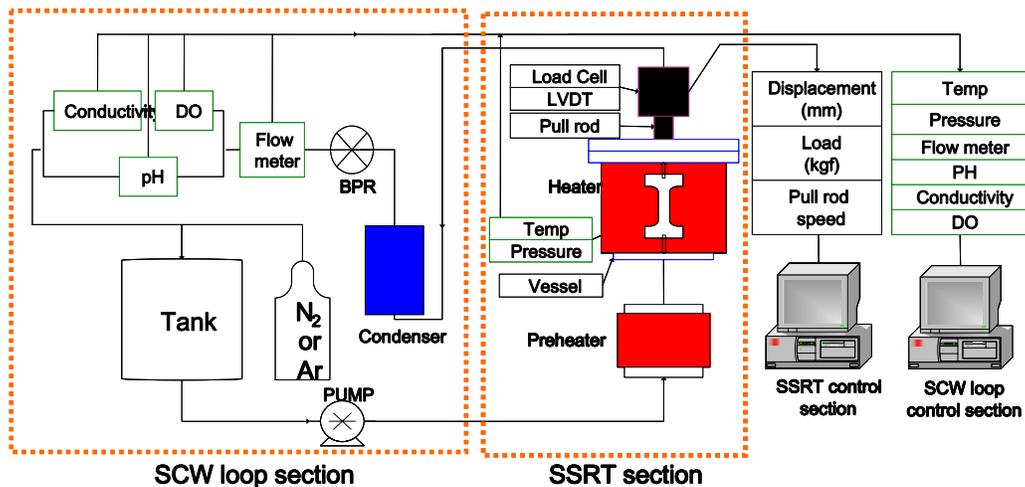
Figure 89 Schematic Diagram of SSRT Facility.

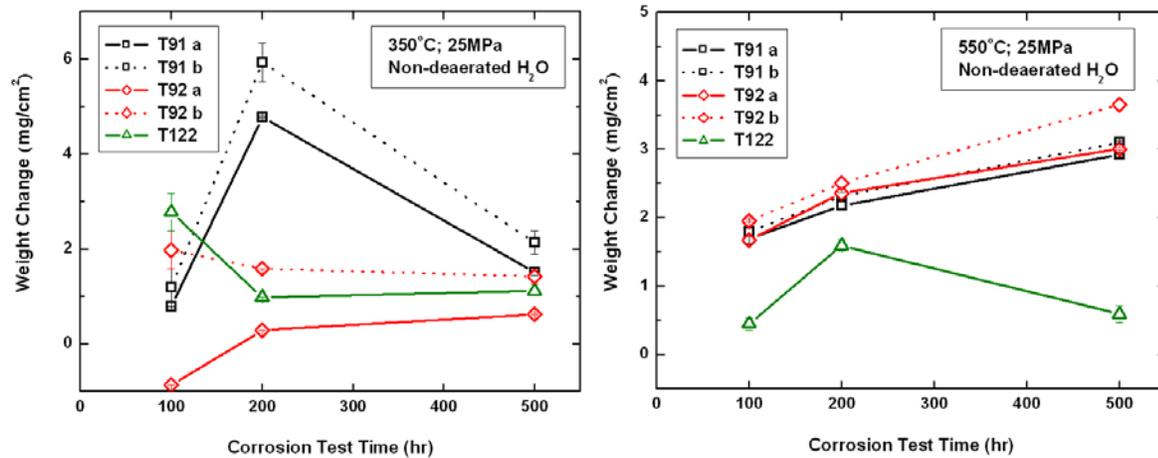
Figure 93 SCW corrosion results comparison at 350 and 550°C.

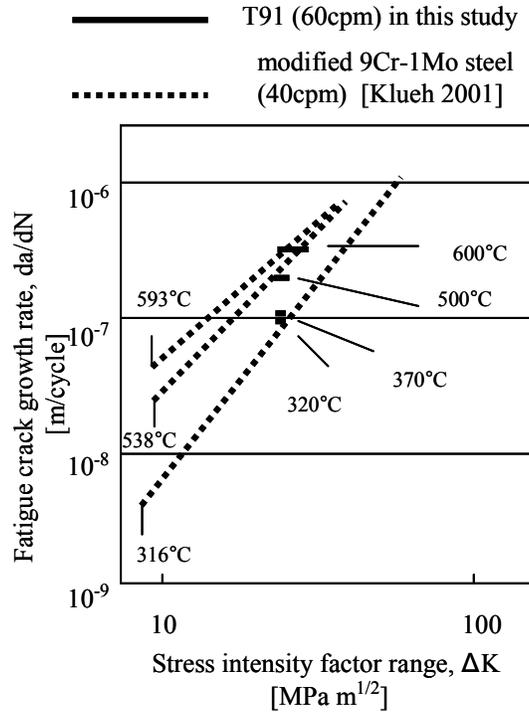
Figure 96 Comparison of fatigue crack growth rates of T91 with those of 9Cr steel from a literature.

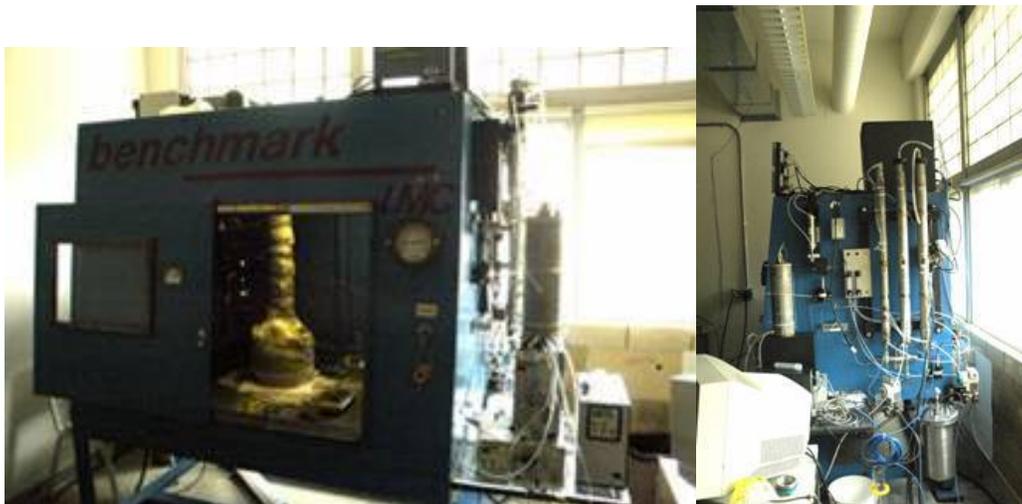
Figure 100 Supercritical water corrosion cell at the University of Wisconsin, used for the 600oC SCW corrosion tests.

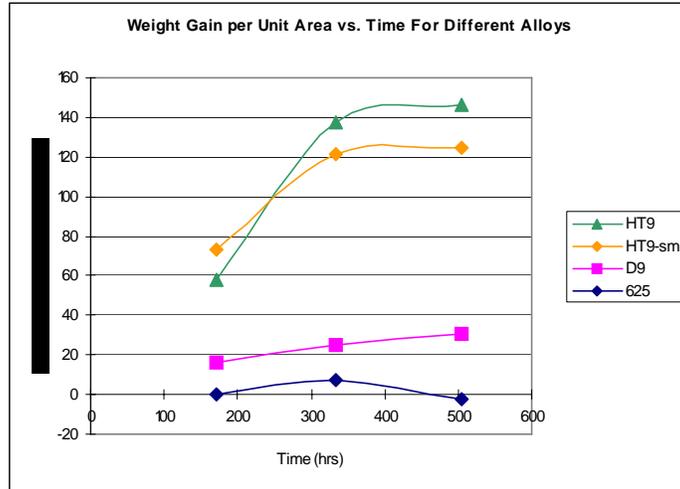
Figure 106 Weight gain measurements of HT9 steel in the as-received and oxygen ion implanted conditions after exposure to supercritical water at 500°C for periods of 1, 2, and 3 weeks. For comparison similar measurements of Ni-bearing, high Cr alloys, D9 and Inconel 625 are also shown.

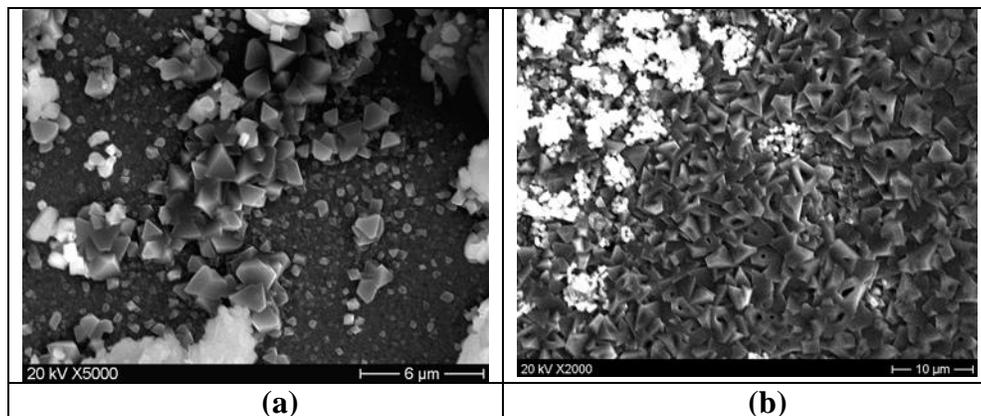
Figure 107 SEM surface plan view of the HT9 steel showing corrosion due to oxide particulate formation after exposure to supercritical water at 500°C for 1 week (a) as-received condition and (b) oxygen ion implanted condition. Higher density of oxide particulates is observed in the surface modified alloy.

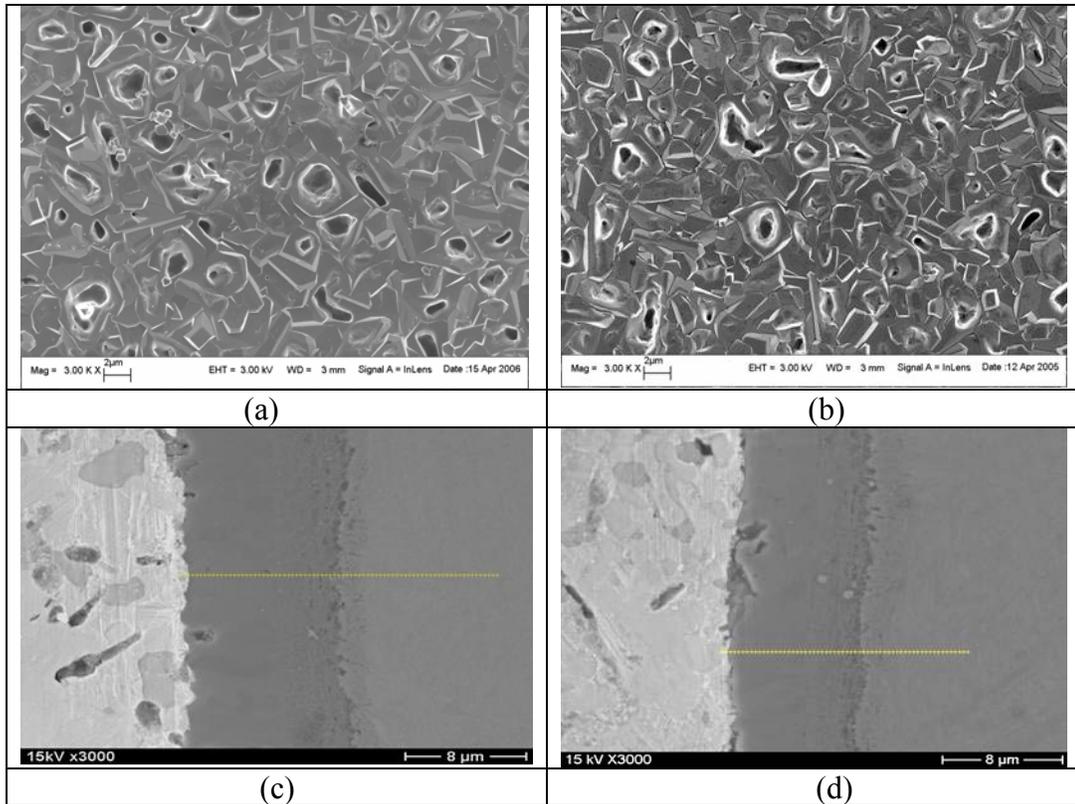
Figure 108 SEM images of the oxide corrosion product formed on steel HT9 after exposure to SCW at 500°C for 3 weeks, (a) untreated plan view, (b) O^+ ion implanted plan view, (c) untreated cross-sectional view, and (d) O^+ ion implanted cross-sectional view.

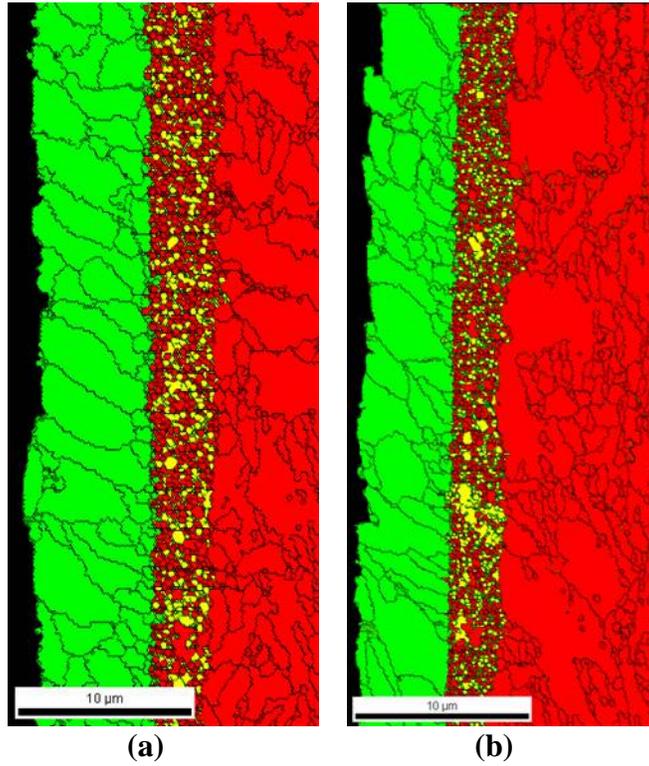
Figure 109 Electron Back Scattered Diffraction (EBSD) images of the cross-section of the oxide formed on HT9 steel after exposure to SCW at 500°C for 3 weeks, (a) as-received and (b) O⁺ implanted. Layer indicated by green is magnetite, whereas the inner yellow/red layer was identified to be a Fe-Cr spinel compound.

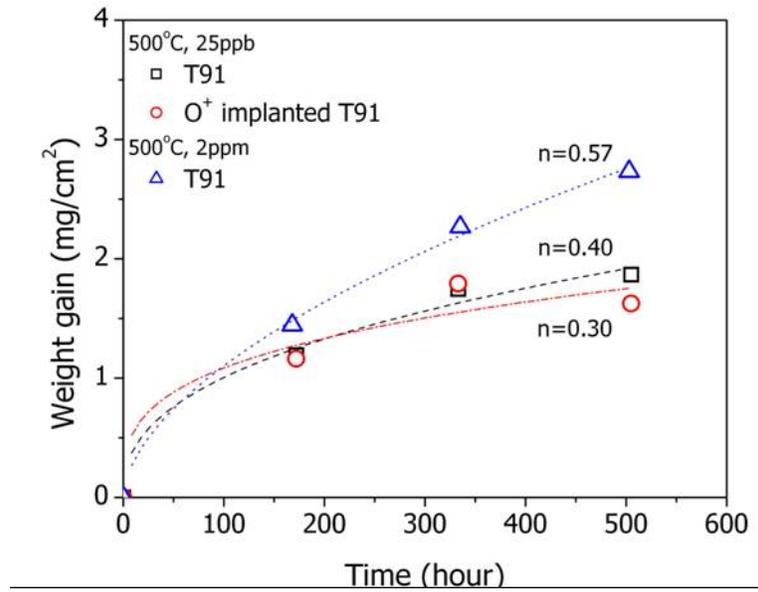
Figure 110 Weight gain measurements of T91 alloy in the as-received and oxygen ion implanted conditions after exposure to supercritical water at 500°C (25 ppb oxygen) for periods of 1, 2, and 3 weeks. For comparison results of weight gain for exposure in supercritical water at 500°C (2ppm oxygen) is also shown.

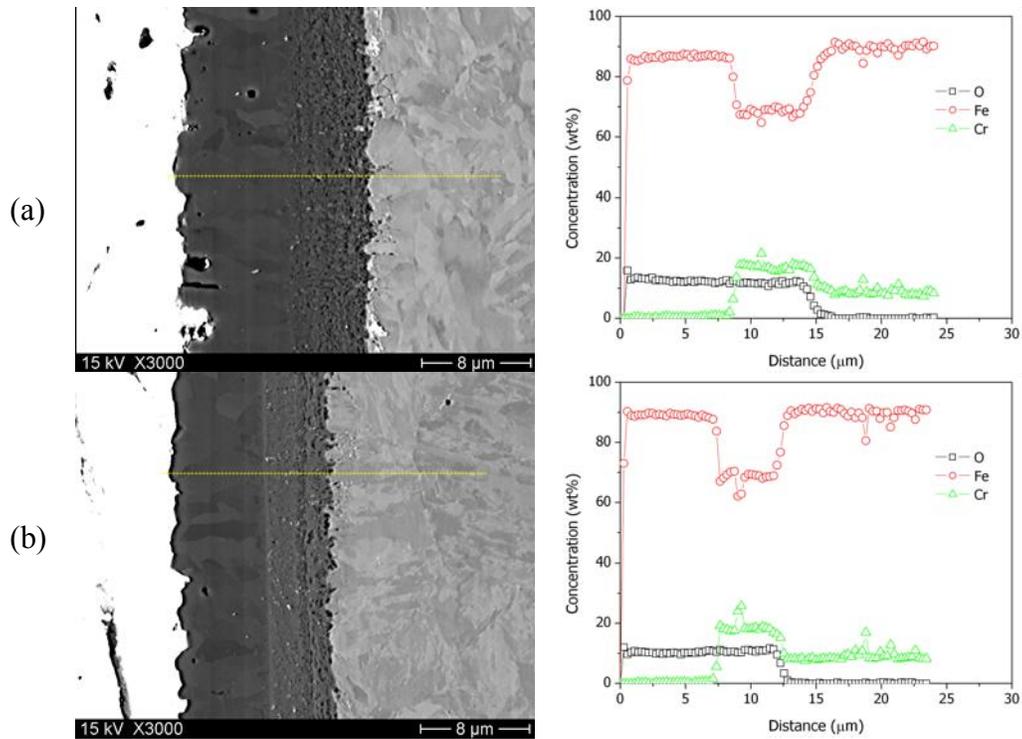
Figure 111 SEM cross-sectional image and corresponding EDS analysis of the oxide layer formed on T91 steel after exposure to supercritical water at 500°C for 3 weeks. (a) as-received and (b) O⁺ ion implanted conditions.

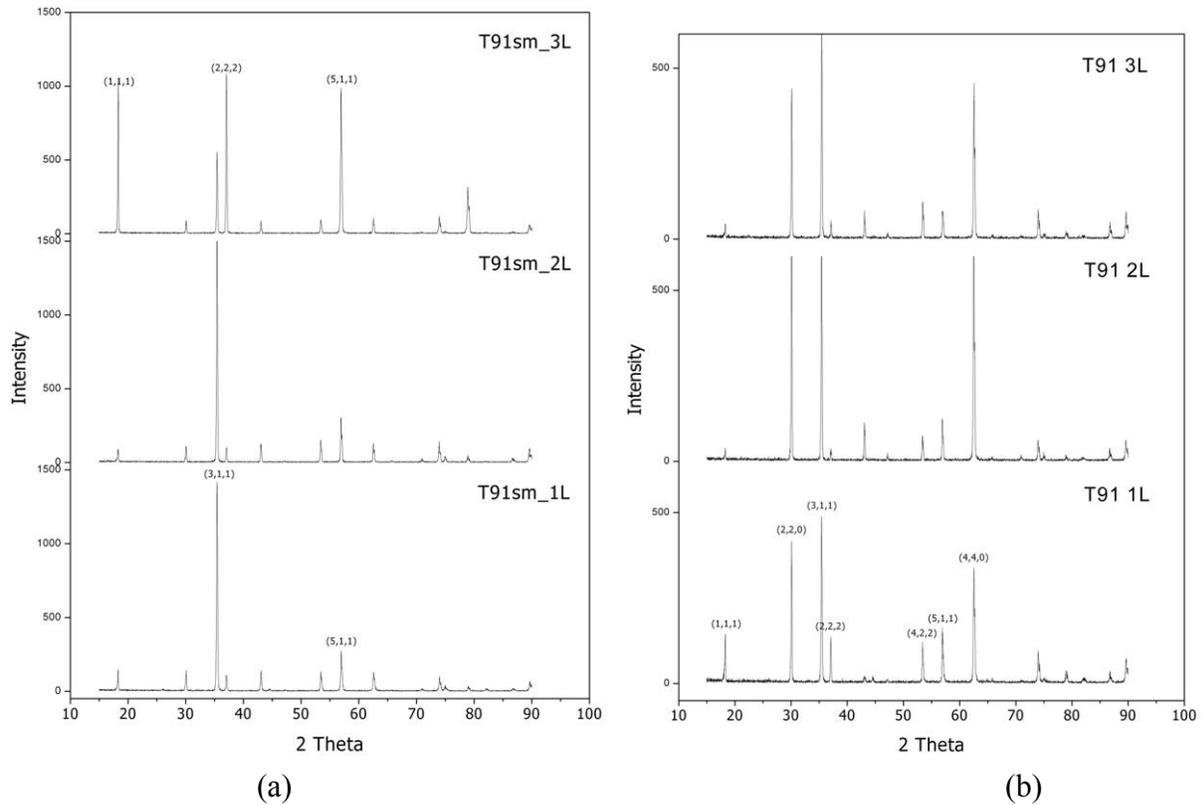
Figure 112 X-ray diffraction patterns for T91 steel after exposure to supercritical water at 500oC for 1, 2, and 3 weeks (a) as-received and (b) after surface modification by oxygen ion implantation.
