Final Technical Report

INERI 2003-008-K

Developing and Evaluating Candidate
Materials for Generation IV Supercritical
Water Reactors

J. I. Cole, J. L. Rempe and T. C. Totemeier, Idaho National
Laboratory

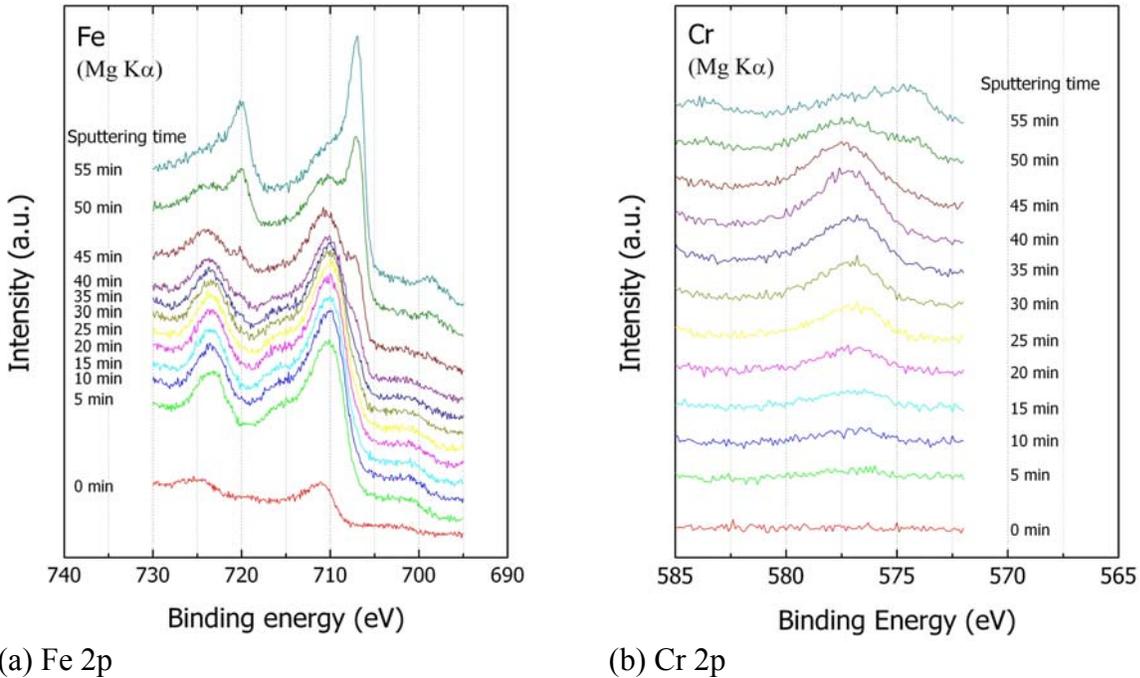
Figure 114 Fe 2p and Cr 2p core level XPS spectra of the oxygen ion implanted T91 as a function of depth below the surface. Sputter time is proportional to the depth below the surface at which the analysis was performed. Sputter rate was 3nm/minute.

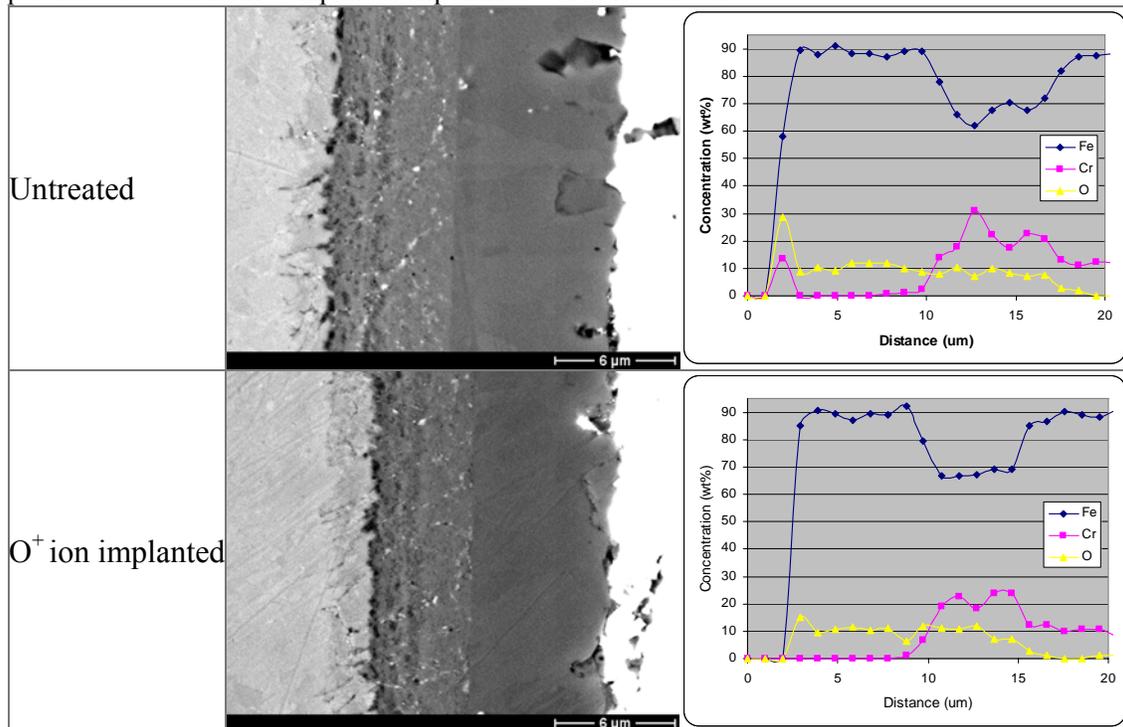
Figure 116 Cross-section of the oxide layer developed on HCM12A steel in the untreated and oxygen ion implanted conditions after exposure to SCW at 500°C for 3 weeks and corresponding EDS line scan compositional analysis across the oxide layer.

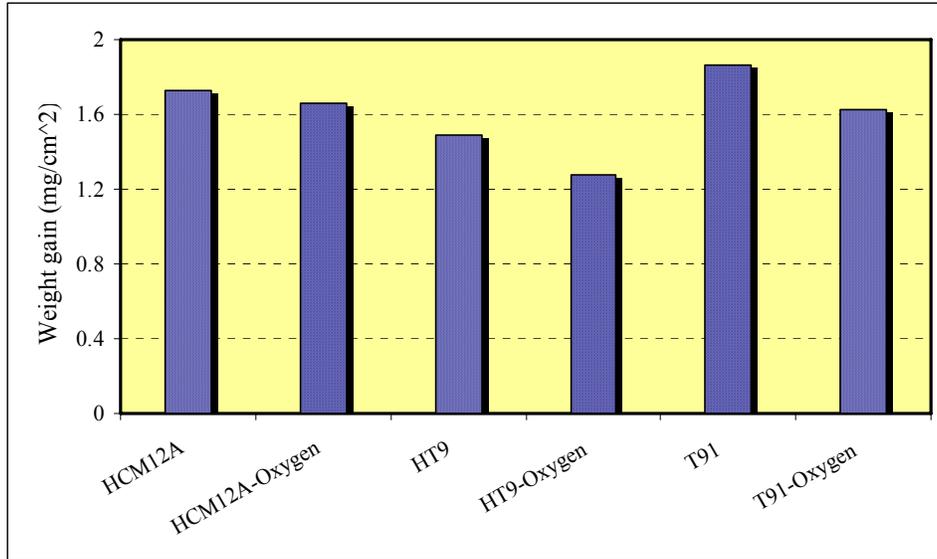
Figure 117 Results of weight gain measurements (per unit area) of the as-received and oxygen ion implanted steels after 3 weeks exposure to supercritical water at 500°C.

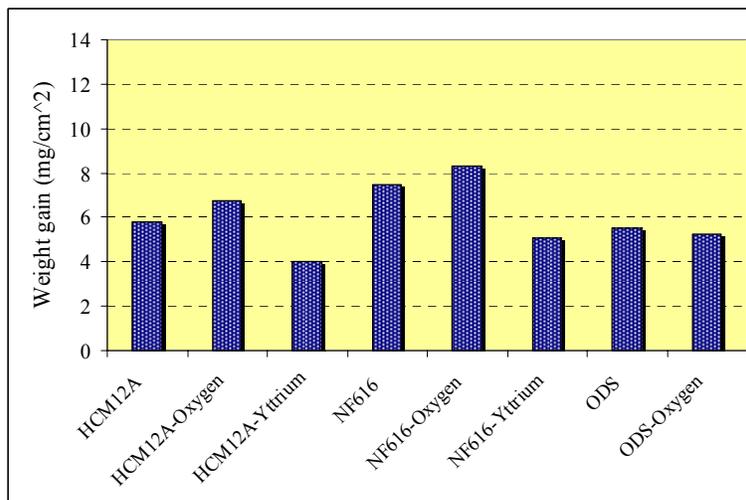
Figure 118 Results of weight gain measurements of ferritic steel samples in various surface conditions after exposure to SCW at 600°C and with an oxygen content of 25ppb for 2 weeks.

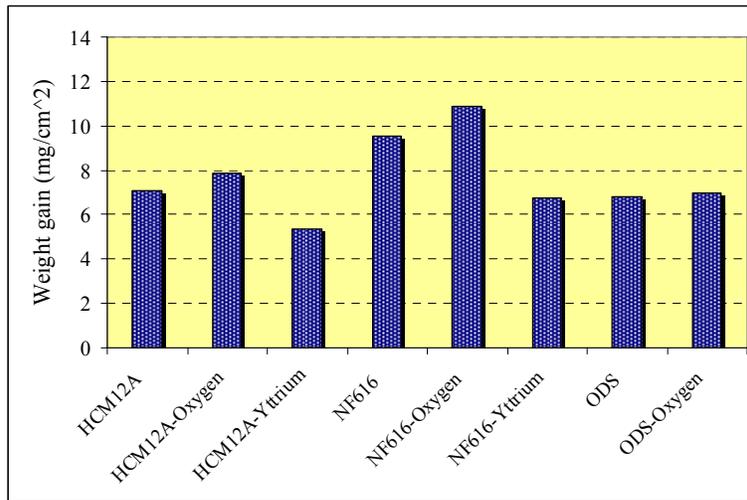
Figure 119 Results of weight gain measurements of ferritic steel samples in various surface conditions after exposure to SCW at 600°C and with an oxygen content of 25ppb for 4weeks.

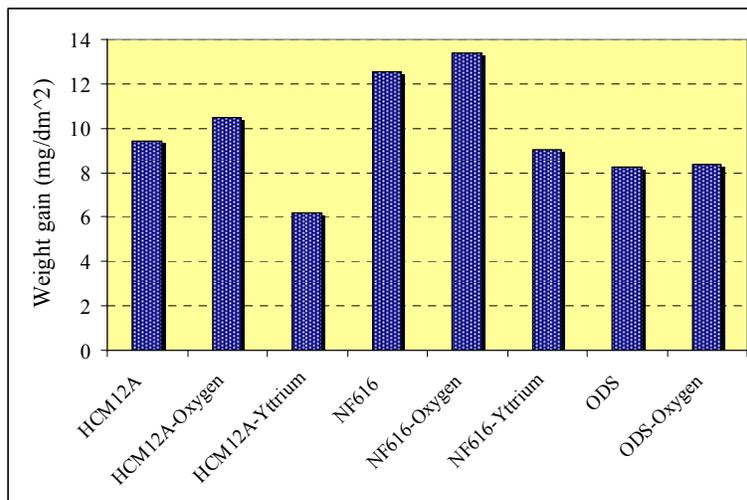
Figure 120 Results of weight gain measurements of ferritic steel samples in various surface conditions after exposure to SCW at 600°C and with an oxygen content of 25ppb for 6 weeks.

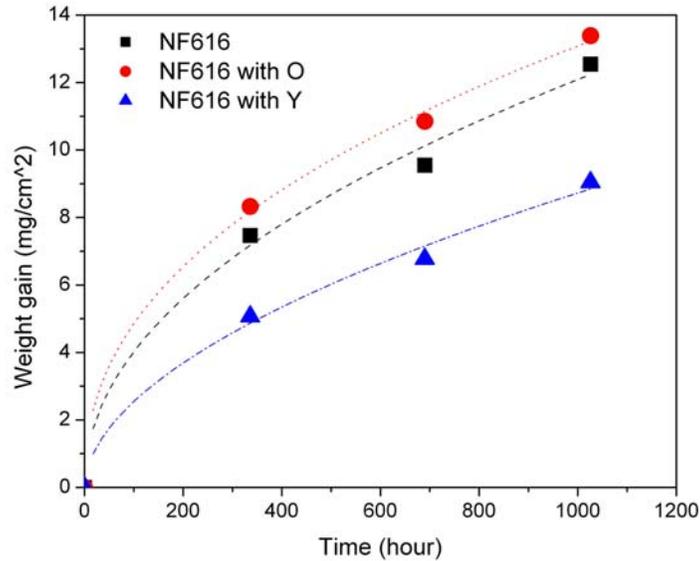
Figure 121 Results of weight gain measurements of ferritic steel NF616 in various surface treated conditions after exposure to SCW at 600°C and with an oxygen content of 25ppb as a function of exposure time.

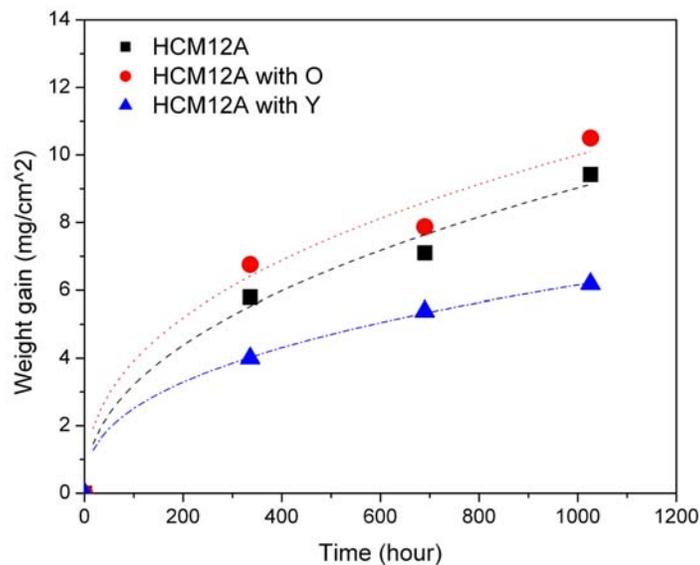
Figure 122 Results of weight gain measurements of ferritic steel HCM12A in various surface treated conditions after exposure to SCW at 600°C and with an oxygen content of 25ppb as a function of exposure time.

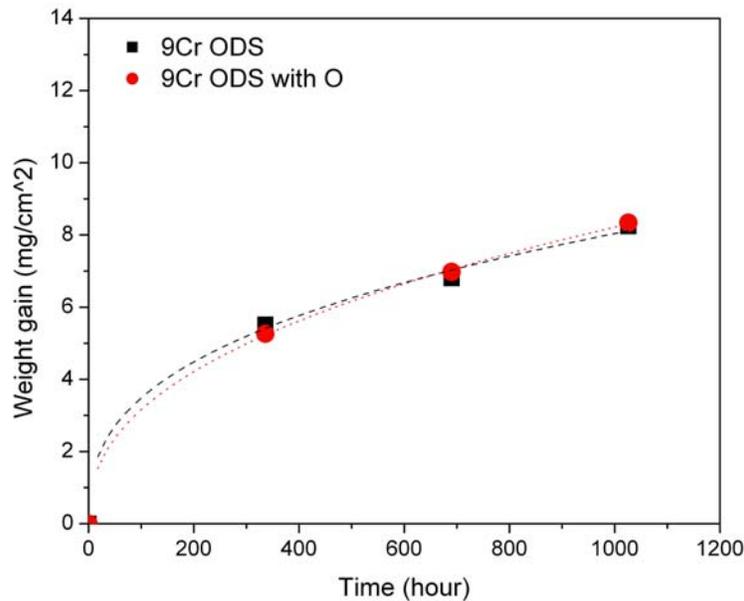
Figure 123 Results of weight gain measurements of ODS ferritic steel in various surface treated conditions after exposure to SCW at 600oC and with an oxygen content of 25ppb as a function of exposure time.

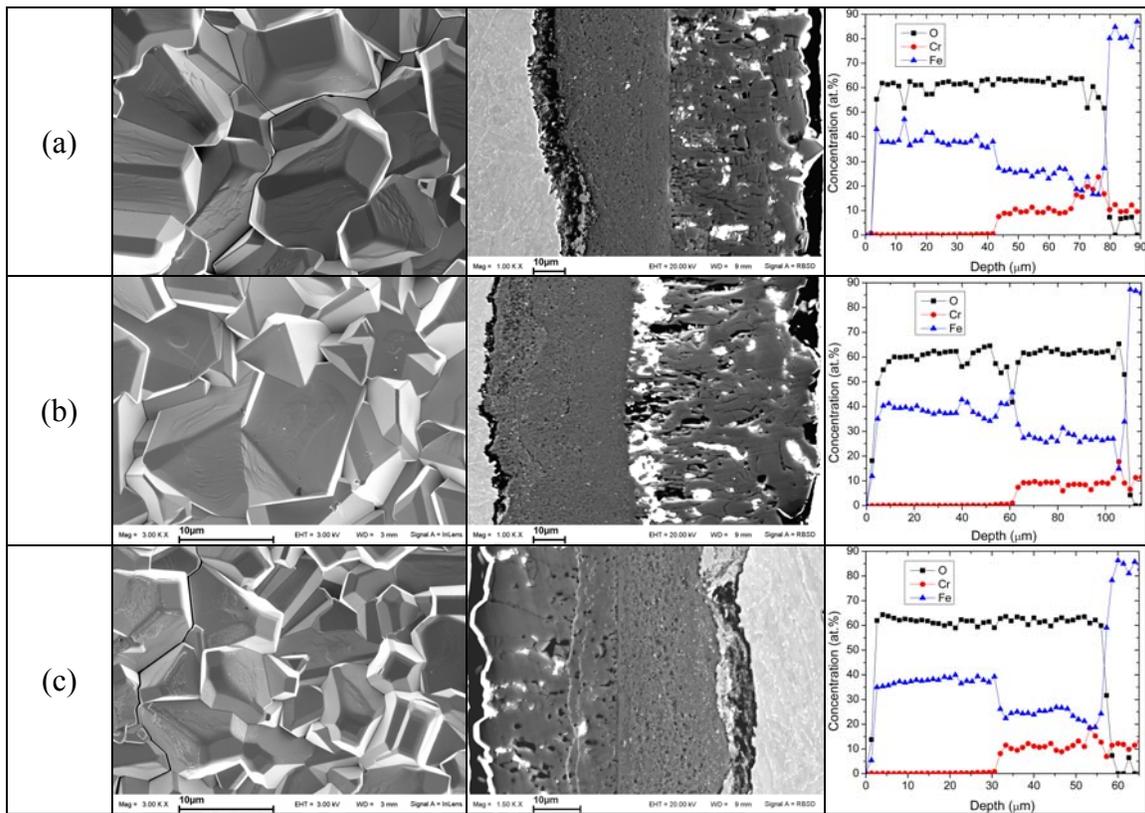
Figure 124 SEM images of the oxide formed on steel HCM12A in various surface conditions after exposure to SCW at 600°C for 6 weeks and the corresponding compositional line-scan across the oxide layer (a) as-received, control, (b) oxygen ion implanted, and (c) yttrium surface treated conditions.

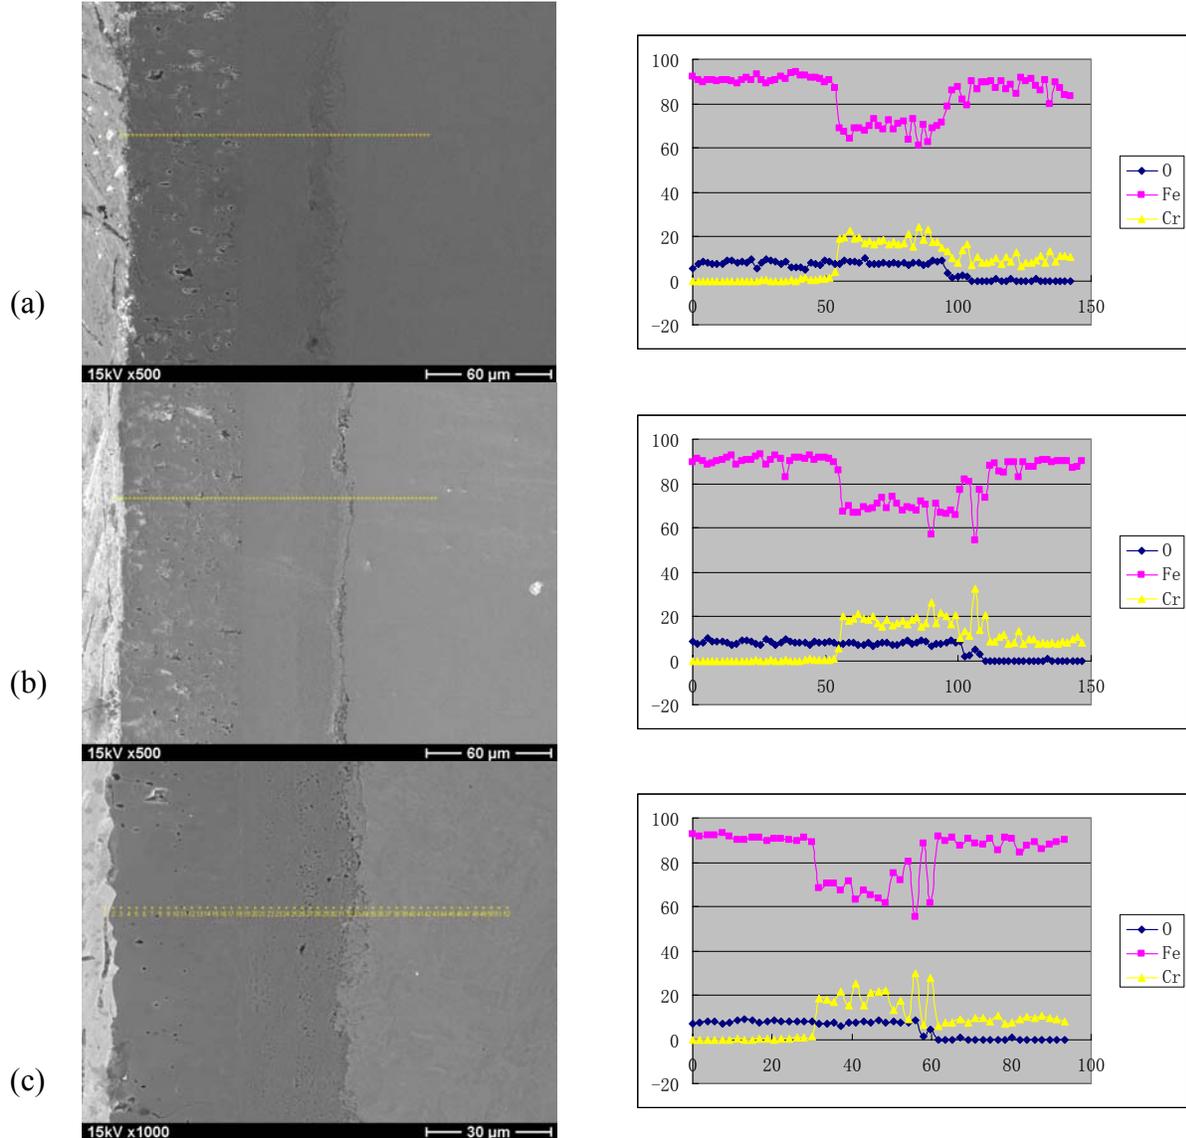
Figure 127 Oxide cross-sectional SEM images of the oxide layer formed on NF616 steel after exposure to SCW at 600°C for 6 weeks and corresponding EDS line scan compositional analysis , (a) as-received, (b) oxygen ion implanted, and (c) yttrium surface treated.

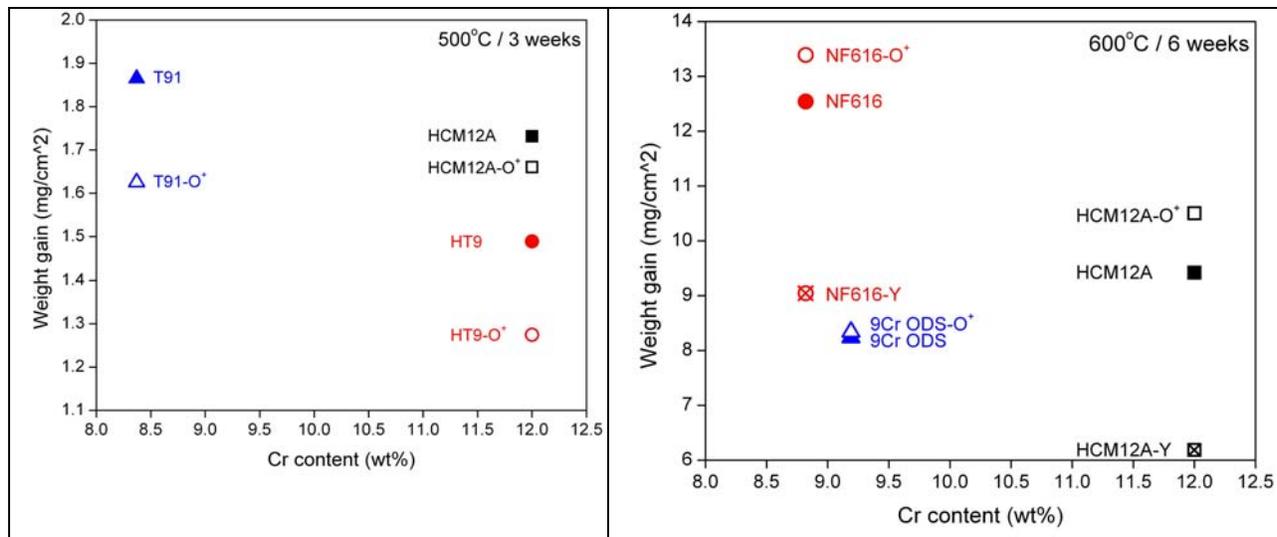
Figure 129 Performance of various steels and surface treatments in SCW at 500°C and 600°C (25 ppb oxygen). Note that performance rating of the steels can be altered by surface modification.

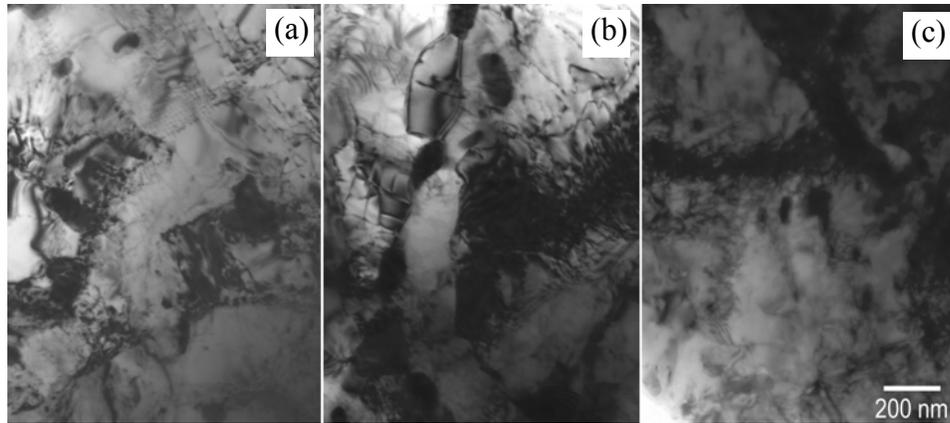
Figure 130 Low magnification overview of microstructure for alloy HCM12A irradiated with Ni ion at 500°C to (a) unirradiated, (b) 5 dpa and (c) 50 dpa.

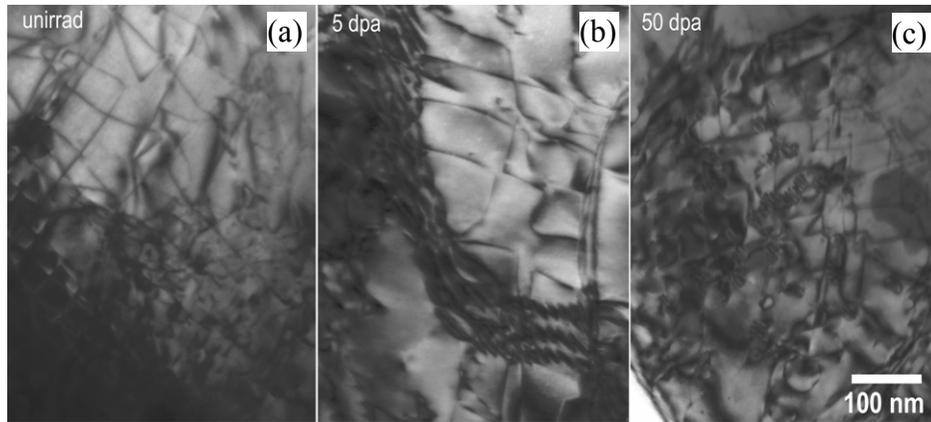
Figure 131 Dislocation microstructure for alloy HCM12A irradiated with Ni ion at 500°C to (a) unirradiated, (b) 5 dpa and (c) 50 dpa.

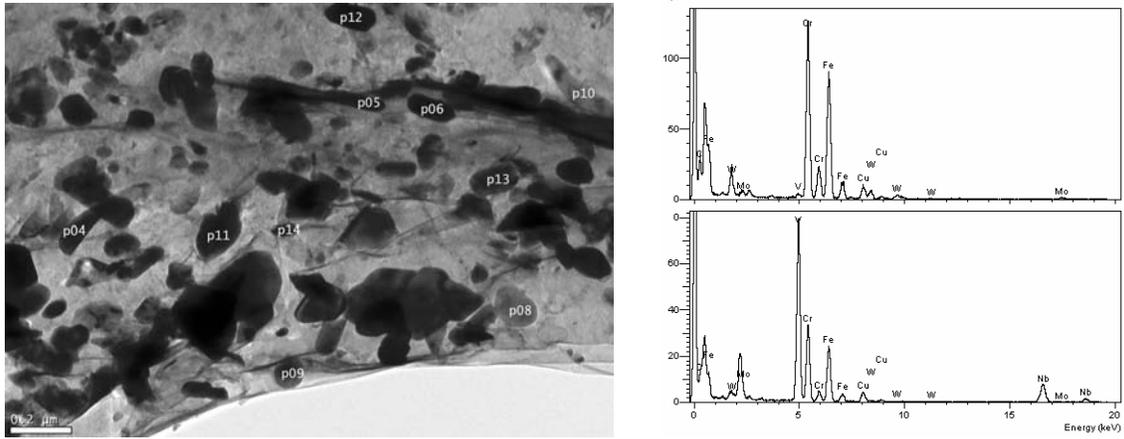
Figure 132 in HCM12A irradiated with Ni ions at 500°C to 5 dpa. Those marked p04, p08 and p11 are V-Nb precipitates. The rest are mostly M23C6 type precipitates.

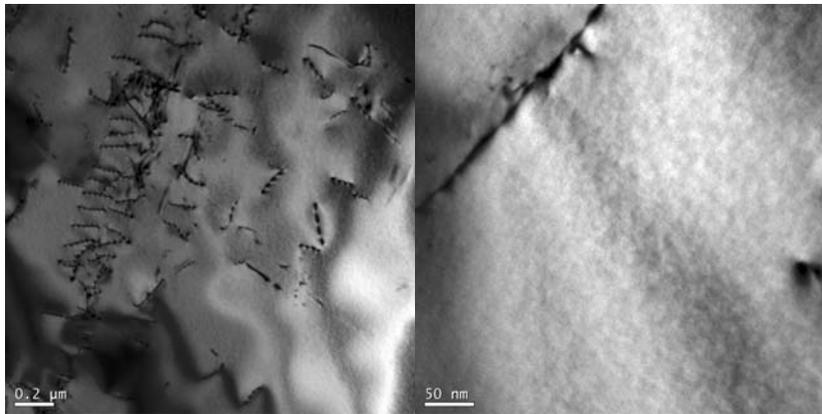
Figure 133 Unirradiated microstructure of alloy 800H (imaged with $g=200$ diffraction) reveals dislocations in low magnification (left) and high magnification (right). The alloy has a relatively high dislocation density considering it was heat-treated at 1177°C for 2.25 hours.

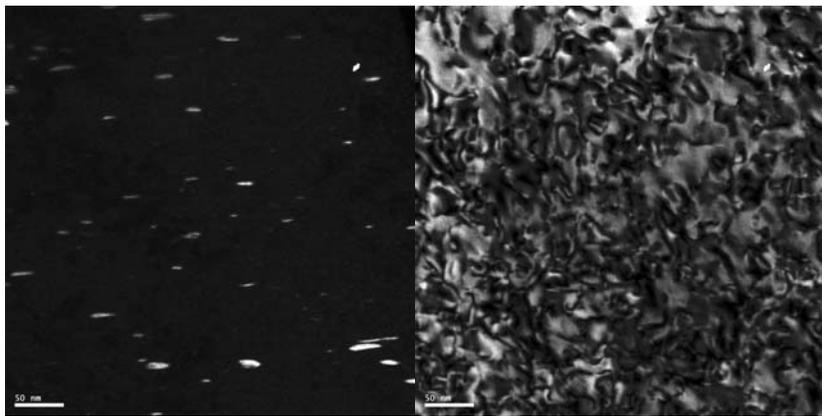
Figure 134 Microstructure in alloy 800H irradiated with Ni ion at 500°C to dose of 5 dpa. Bright filed image (left) showing dislocation loops under $g=200$ and the rel-rod dark filed image (right) showing $\frac{1}{4}$ of the faulted dislocation loops.

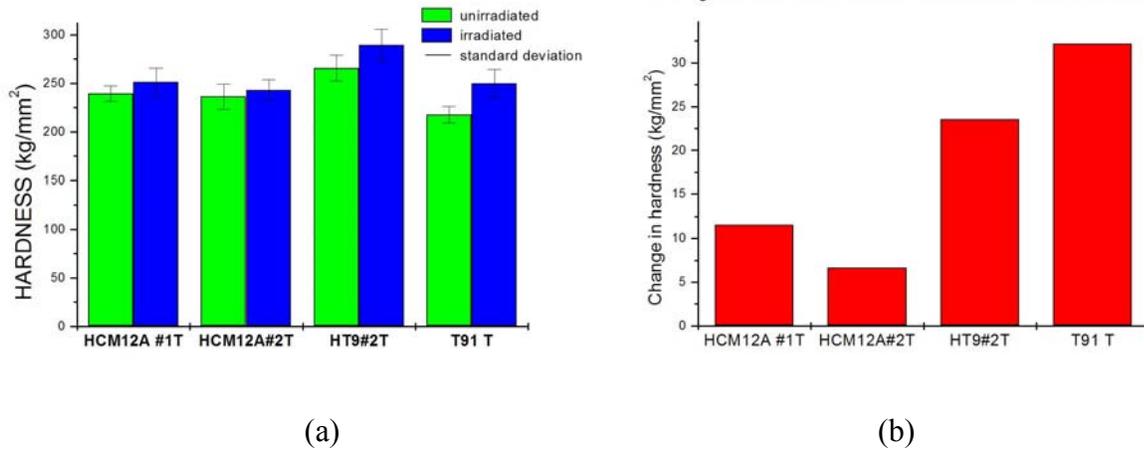
Figure 138 (a) Hardness of unirradiated and 7 dpa irradiated sample (b) Hardness changes in samples irradiated to 7 dpa.

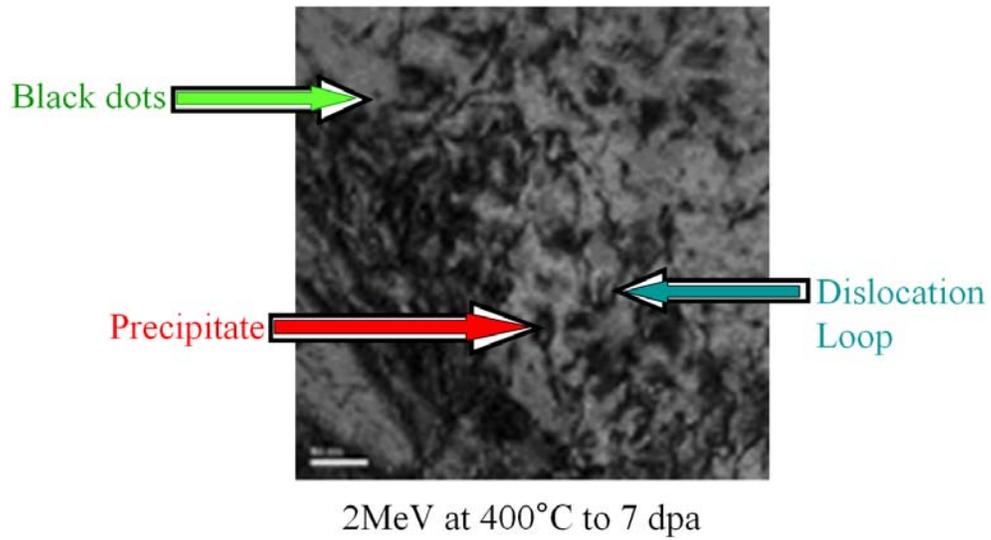
Figure 139 Dislocation and precipitate structure in proton irradiated alloy T91.

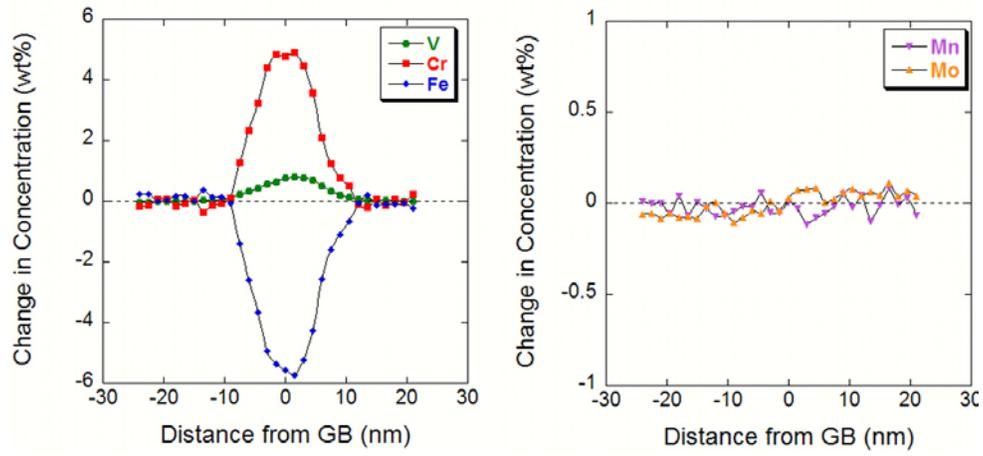
Figure 141 Grain boundary chemistry profiles of alloy T91 irradiated with protons.

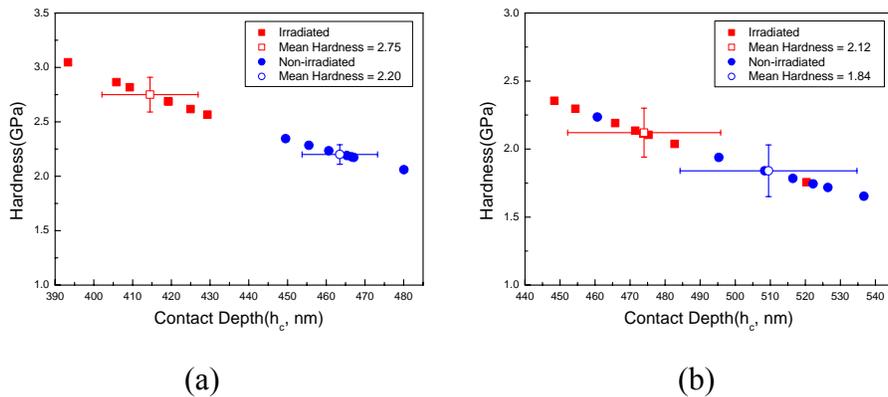
Figure 143 (a) Hardness of irradiated and unirradiated MA956 alloy (b) hardness of irradiated and unirradiated T91 alloy.

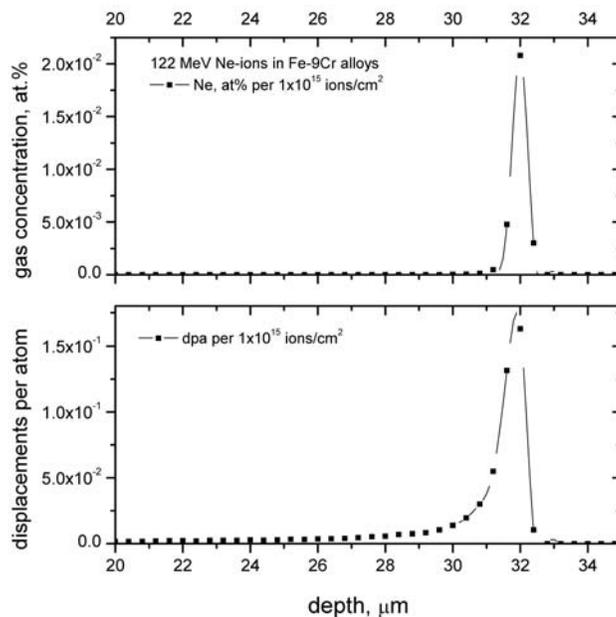
Figure 144 Damage profile of Fe-9Cr steel when irradiated with 122 MeV Ne ions; peak damage range at about 32 micron.

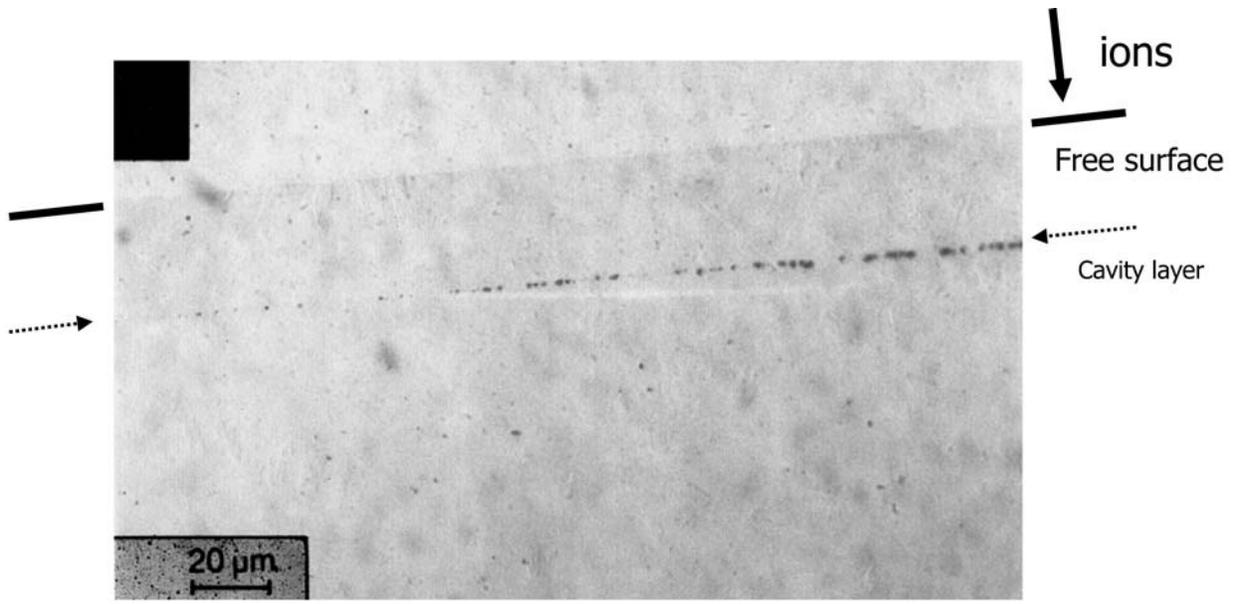
Figure 145 Optical micrograph of T92, irradiated with 4.5 dpa of 122 MeV Ne ions at 520°C.

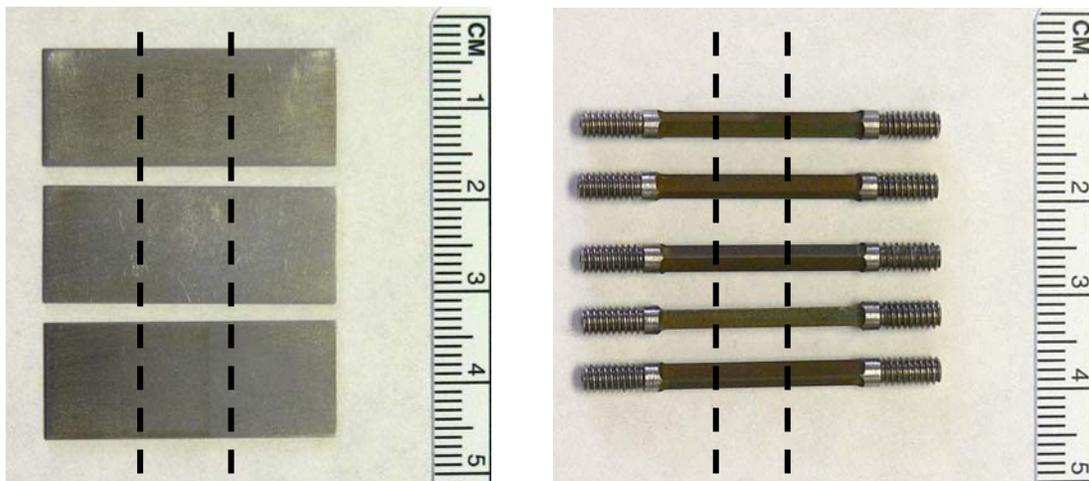
Figure 146 Images of weld samples. Area between dashed lines indicate the approximate location and width of the weld zone.

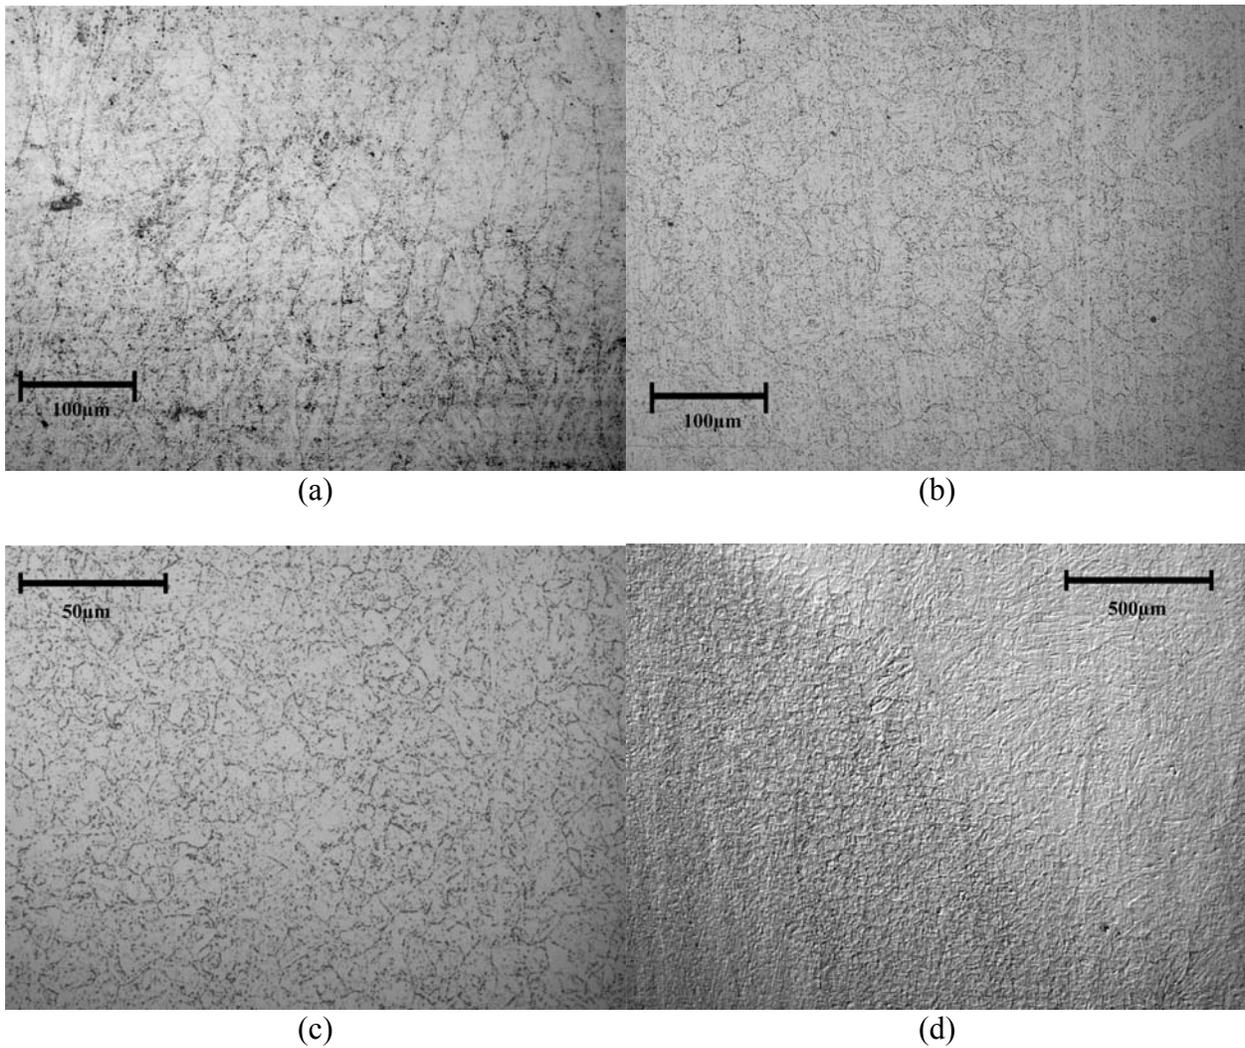
Figure 147 Optical images of weld and base metal in alloy T91: (a) Weld Zone, (b) HAZ, (c) Base Metal and (d) Interface between zones.
